Office of the City Engineer

MEMO

Re: Traffic Study - Intersection of Ohio St. and Ridgeway Ave.

From: Ara P. Molitor, P.E.

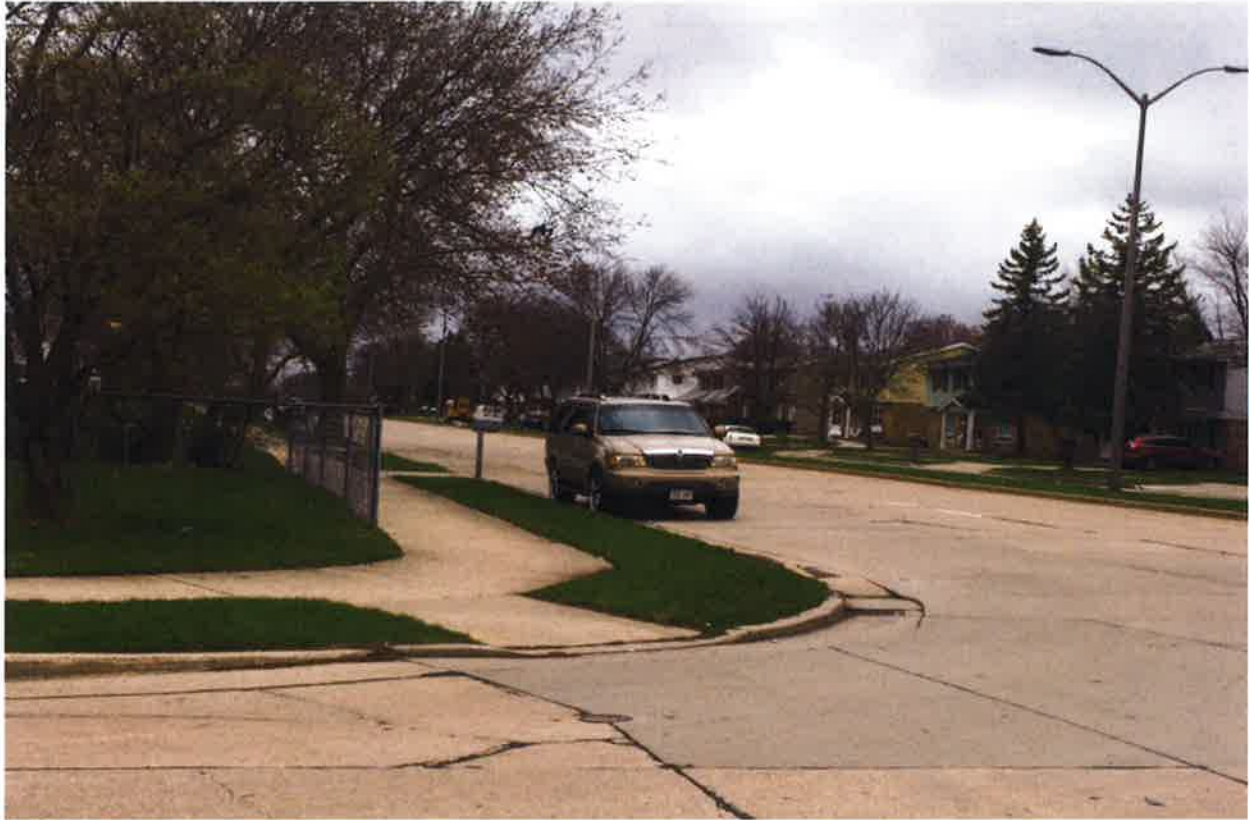
The vision triangles for the east approach to the intersection are obstructed by parked vehicles, fences and trees in the terrace. The terrace at the intersection is approximately 6 feet wide, in all directions. The vision triangle to the north is not critical because the motorist has 2 driving lanes, a parking lane and a median to cross before it is in conflict with traffic which allows for wide open view of southbound traffic.

The above picture is the view from a vehicle legally stopped at the intersection on Ridgeway and looking south towards northbound traffic. At this time there is only one vehicle parked on the east side of the roadway obscuring the view of the stopped motorist, but you can see if there were more vehicle strung out behind the one, it would completely block the motorist view of oncoming northbound traffic. The fence and the tree also contribute to the lack of vision but they are not the major contributing factors. This vision triangle can be and usually is completely blocked for the view of the motorist. (Note: the 1st driveway is 75' +/- from the corner, 2nd drive – 155' +/- and the tree 180' +/-)

Instruct the sign shop personnel to install “No Parking” signs at approximately 150 feet south of the corner and eliminate parking at all times from the second driveway to the corner.
