Fire Station 6 Space and Operational Issues

City of Racine
Fire Department - Fire Station 6
 Space Needs Program

FGM ARCHITECTS
 March 13, 2018
 FGM #: 18-2434.01

**SECTION 5.6
FIRE STATION NO. 6 -
EXISTING CONDITION
ANALYSIS**

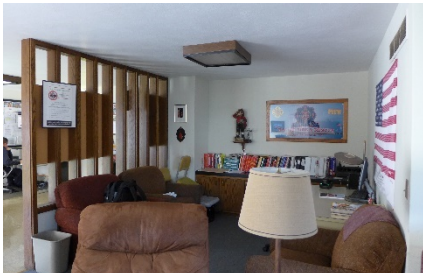
Office Area in Dayroom

- An office is located within the officer's bunk within the private side of the station. Space is small, and access is congested through the living quarters.
- Additional office area is located adjacent to the dayroom in the living quarters. The space is appropriate for use but does not provide a privacy if required.

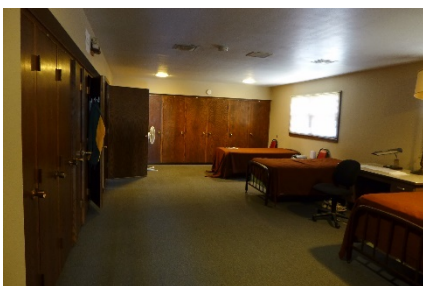
- The department utilizes a rack room concept for its private (sleeping) quarters at all stations. The room contains bunks and lockers for all shifts. This is the only station that does not provide bunks for each person on shift. This layout maintains the most flexibility but does not address gender concerns within the facility.
- No female toilet/ shower facilities are provided within the facility.
- Separate changing rooms should be provided to accommodate gender.
- Toilet/ shower conditions are undersized.

Private Quarters – Bunk Room

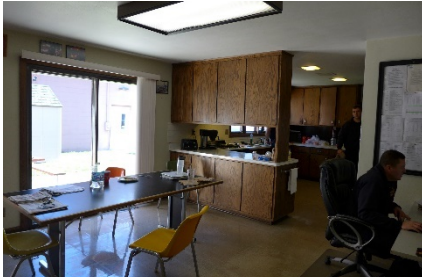
Dining/ Kitchen

- The living quarters are located adjacent to the bay on the first floor. A buffer zone is provided between spaces to maintain isolation between cold and hot zones.
- The kitchen and dining room is undersized for staff use, not providing enough storage.
- The facility has multiple levels that are not accessible.

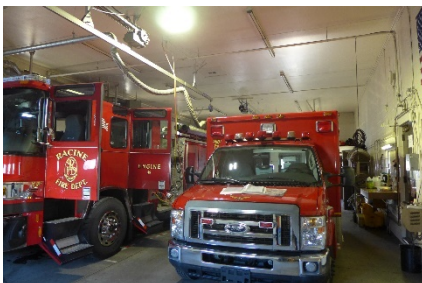
- Turnout gear storage is stored directly on the bay floor, adding to potential contamination.
- No bay support storage is located directly adjacent to the bay floor. The work room is located on the bay floor, congesting access and flow around the vehicles. Equipment and other support is located along the walls of the apparatus bay, creating further congestion and safety concerns. Laundry is located in the basement, which is accessed through the house. This conflicts with national guidelines and defies the 'hot' vs 'cold' zone separation.

Apparatus Bay

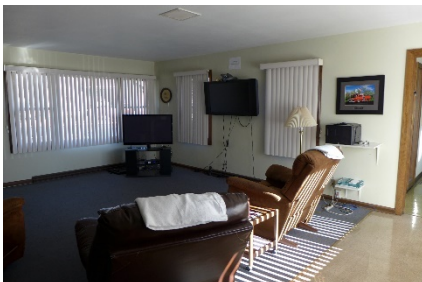
Dayroom - Training

- No training room is provided at this facility. Training occurs within the living quarters. The educational training should occur in a learning environment, whether at a computer, video distribution, vidcon learning experience, etc. Currently any training occurs within the living quarters of the station in living room couches or at the dining room table. These spaces

already pull multi-duty on operation, and don't provide the proper environment to properly nurture and promote learning. The addition of a meeting room, library, and office area that can be used for training during shift will help to keep staff in quarters and reduce the need to pull shifts out of service to maintain training level requirements.

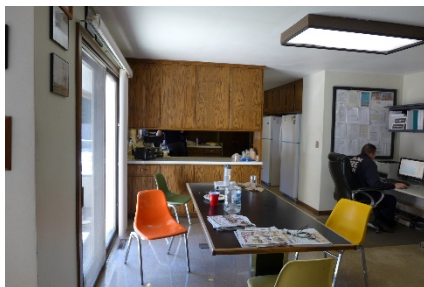
View of dining and kitchen

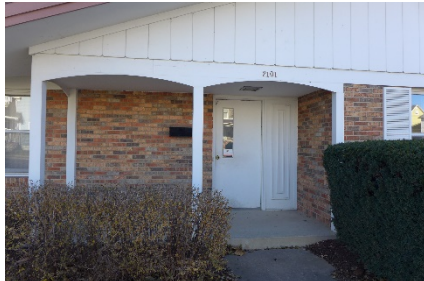
No accessible access to front door

- Both the front entrance and rear entrances to the station are raised above grade approximately 6" and do not have accessible wheelchair ramps.
- The rear entry door does not have the proper ADA approach clearances on both the exterior and interior sides.

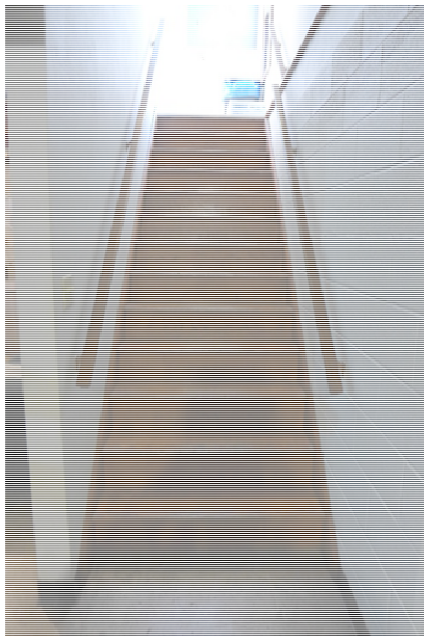
Staircase to basement

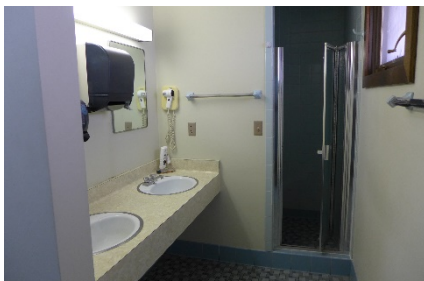
Inaccessible shower stall and accessories

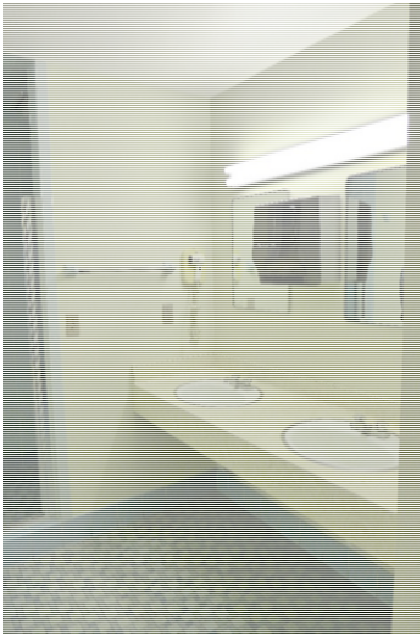
Station has one primary multi-user restroom to serve all firefighters.

Overall not many building code violations were observed during the building assessment review. The major violation is the lack of separated toilet rooms for women and men. Currently there is one large restroom with 2 toilets, 2 showers and 4 sinks. The building code requires separate facilities be provided for each sex.

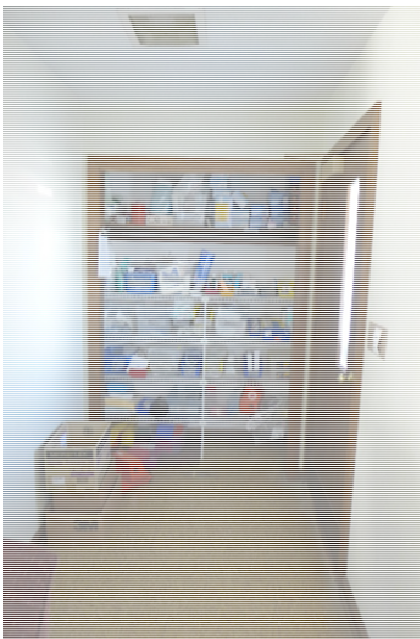
Lack of security for EMS supplies

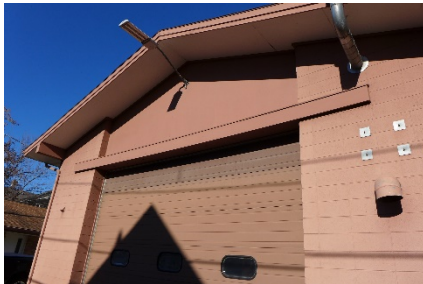
Sagging beam at overhead door

- The main support above the overhead bay doors appears to be sagging
- The concrete apron at the front of the apparatus bay has major cracking and spalling.

City of Racine – Fire Station No 6		Type of Item	Priority of Item	Estimated Impact
Item/ Issue	1, 2, 3, 4, 5	a, b, c		
18	Main support lintel over the apparatus bay overhead door is sagging from deflection and should be replaced/ reinforced.	4	b	\$4,000 - \$15,000
19	Repair/ replace major cracks in front bay apron	4	b	\$25,000 - \$35,000
20	Address spalling of masonry and mortar on apparatus bay walls from moisture infiltration and damage	4	b	\$50,000 - \$100,000
21	Replace rear entry door to house that is delaminating	5	b	\$3,000 - \$5,000
22	Increase bay clearance height to meet DOT 13'-10"	1/5	b	\$40,000 - \$50,000
23	Water concerns around building that has caused issues with water in basement, and currently being directed at neighbor	5	b	\$2,000 - \$25,000
24	Repair/ replace rear parking and apron surfaces	5	b	\$20,000 - \$30,000
25	Floor structure is undersized for the live-loads of the current operation and use. Facility not intended to meet essential facility requirements	1/4	b	\$40,000 - TBD

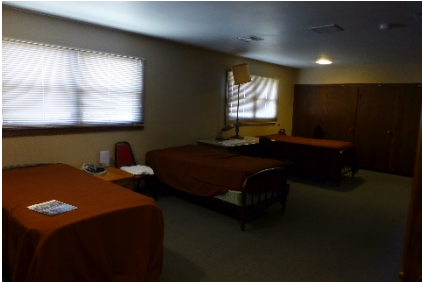
Lack of lighting within bunk area

- All finished within the occupied spaces are residential grade and beyond their useful life.
- There is a lack of adequate lighting throughout the station. Small residential lamps are being used as supplemental lights in several areas.
- The kitchen cabinets and appliances are residential grade. It is not recommended using residential ranges and cabinets in fire stations due to the heavy wear and tear that occurs with multiple people using the space on a daily basis.
- **There is no mechanical air exchange within the building.**

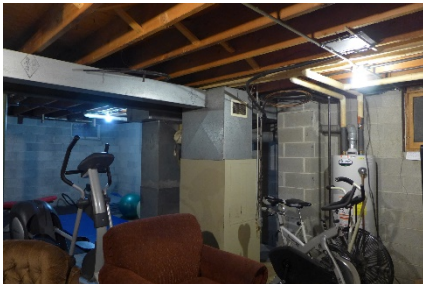
Furnace and water heater

The fire house had been originally designed to be heated with a gas fired furnace, and the apparatus bay with gas fired unit heaters. Central air conditioning is provided by the furnace unit with a remote, outdoor mounted, condensing unit. Ventilation is based on operable windows similar to the typical residential home. No significant issues are reported from station personnel stationed at the fire house.
