Subject: U.S. EPA Safe Drinking Water Act Inspection Report

On February 18-20, 2025, the U.S. Environmental Protection Agency conducted a compliance evaluation inspection of the Racine Waterworks public water system ("System"), PWSID WI2520062, located in Racine, Wisconsin. The purpose of the inspection was to make observations about the site conditions, operation, and monitoring of the System to evaluate compliance with the Safe Drinking Water Act ("SDWA") and regulatory requirements. Please see the enclosed copy of our inspection report.

EPA Inspection Report

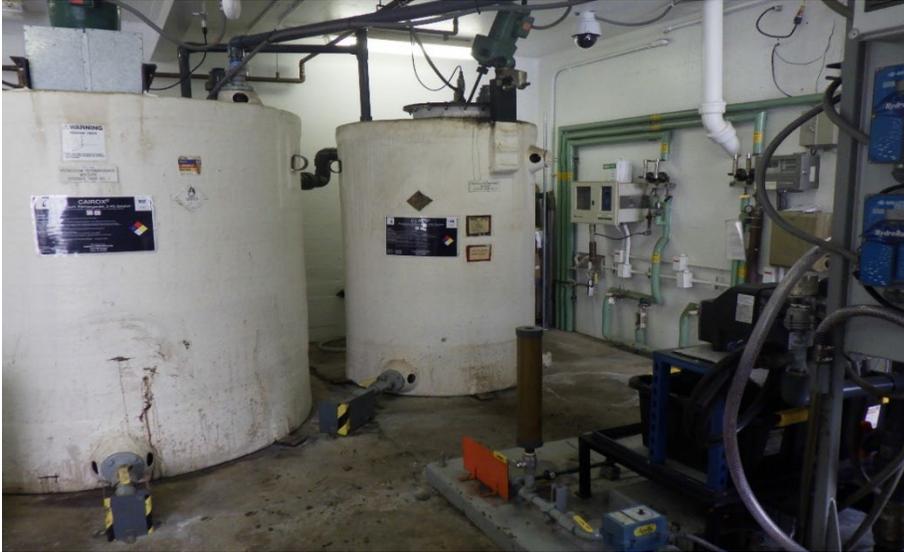
1: R0010086.JPG

Description: Bunker Hill potassium permanganate tanks. Mix tank (1,550 gal) on the left and day tank (585 gal) on the right.

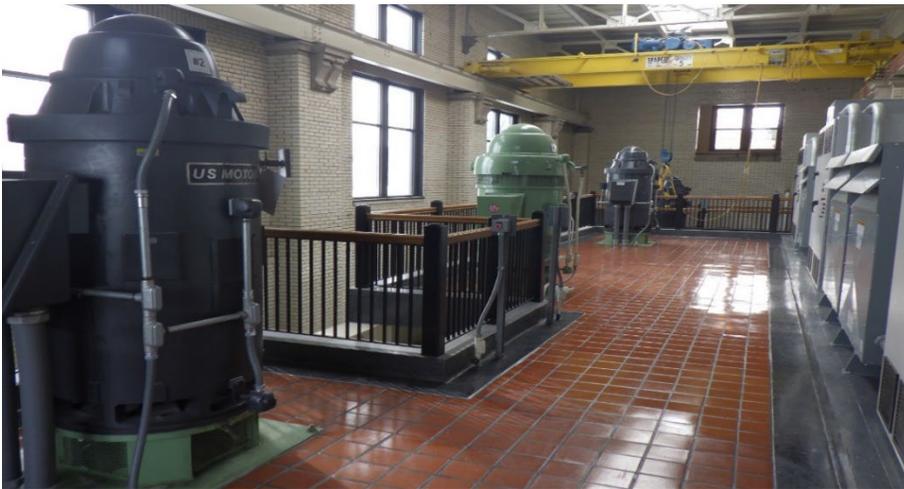
2: R0010087.JPG

Description: Low lift pump room, main floor.

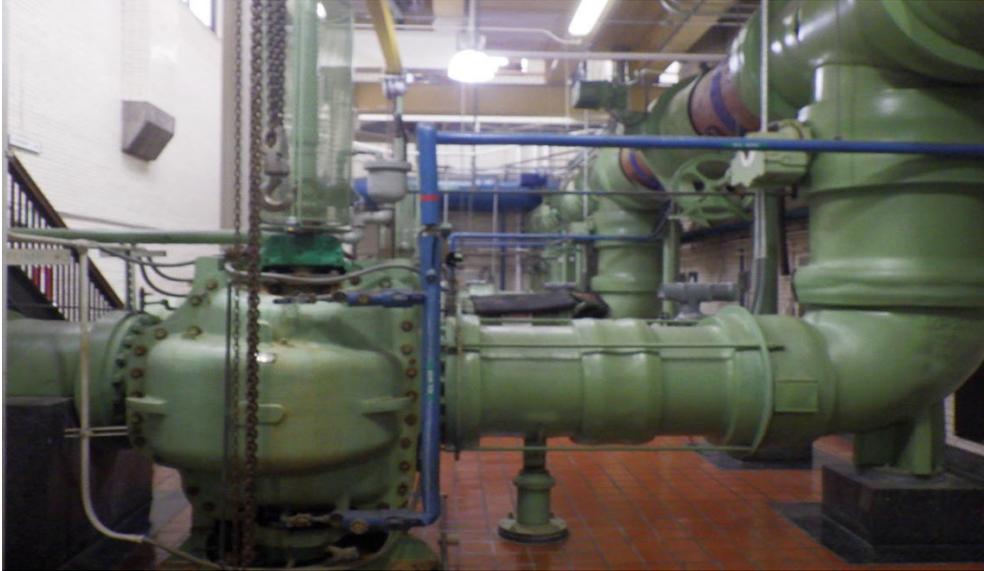
3: R0010088.JPG

Location: Racine Public Water System
Photographer: Amanda Cross
Date/Time: 2/19/2025 2:51 PM
Description: Low lift pump room, basement overview.

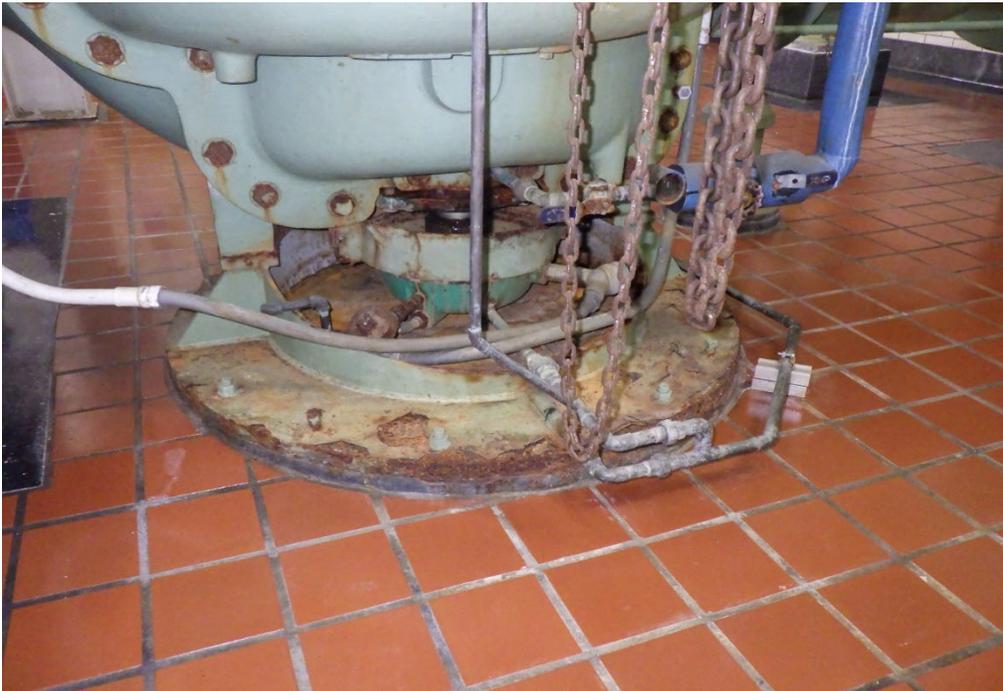
4: R0010089.JPG

All four low lift pumps had corrosion around the base of the pump.

Location: Racine Public Water System
Photographer: Amanda Cross
Date/Time: 2/19/2025 2:52 PM
Description: Close up photo of the base of low lift pump #3 with visible corrosion.

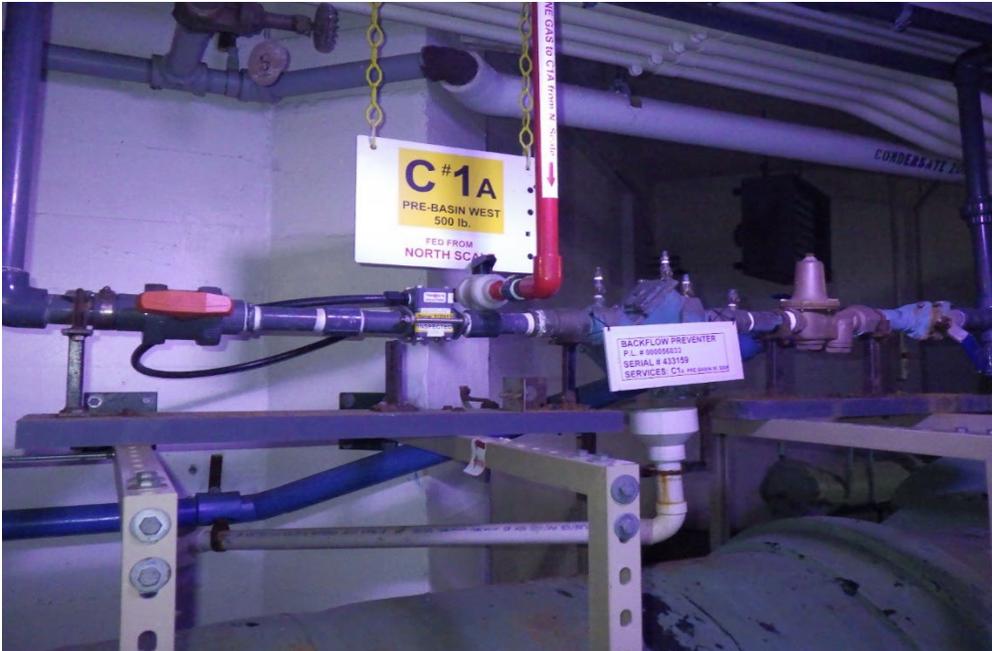
5: R0010090.JPG

Due to the System's design of a centralized central chlorine gas storage room and multiple feed locations, the distance between the feed point and storage location is not minimized.

Utility schematics indicate that there are six feed points for chlorine and extensive piping is required to reach these areas. The System has taken steps to reduce the risk associated with piping in the treatment plant. Chlorine piping is color coded red, labeled, and kept under vacuum pressure. Storage cylinders are equipped with emergency shutoff valves. Chlorine gas detection alarms have been placed within the plant and are routinely maintained. During the inspection, the System was in the process of updating these alarms and had so fare replaced four out of the five alarms in the plant.

Citation: NR 811.39(3)(a): Chemical feed equipment shall be located near points of application to minimize length of feed lines.

Description: West pre-basin raw water line chlorine injector with backflow prevention.

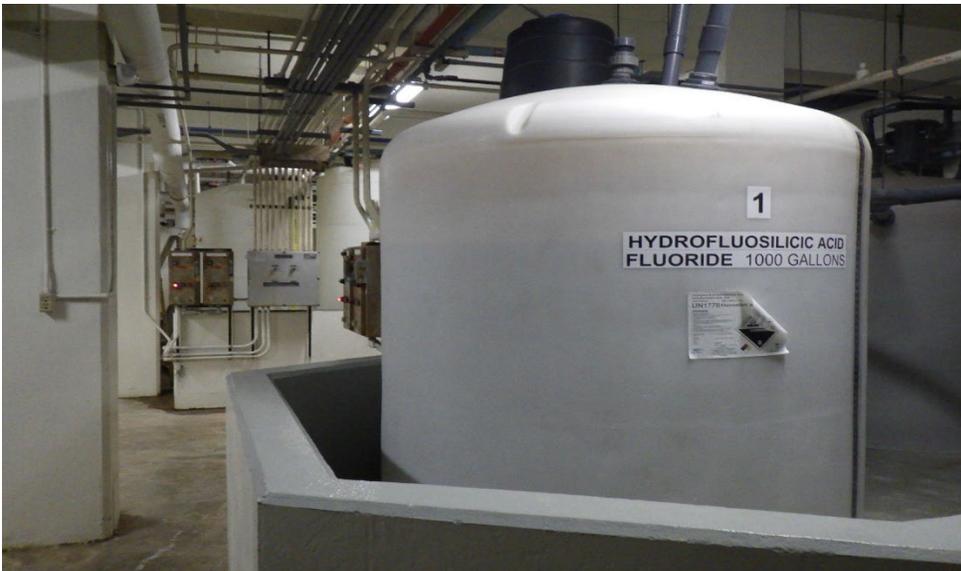
6: R0010091.JPG

Description: Bulk chemical storage room. Fluoride in the foreground and PACL in the background. All chemicals are located in secondary containment.

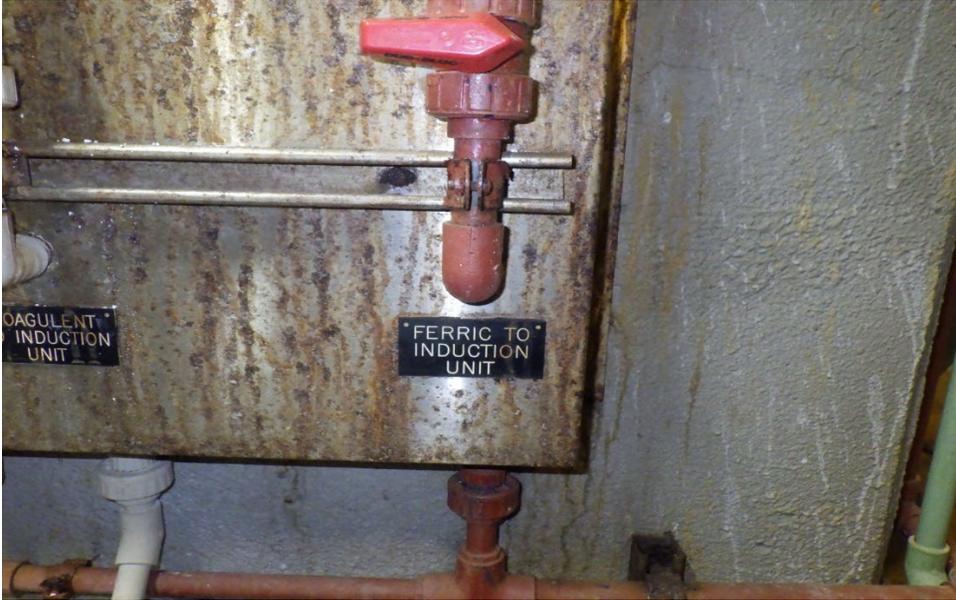
7: R0010092.JPG

Some of the piping in the plant used for PACL was mislabeled as conveying ferric, which was previously run through those pipes but has not been used at the System since 2018.

Citation: NR 811.28(6): In order to facilitate identification of piping in waterworks, it is recommended to use a unique color scheme or labeling.

Location: Racine Public Water System
Photographer: Amanda Cross
Date/Time: 2/19/2025 3:42 PM
Description: Pre-basin 2, chemical feed point labeling.

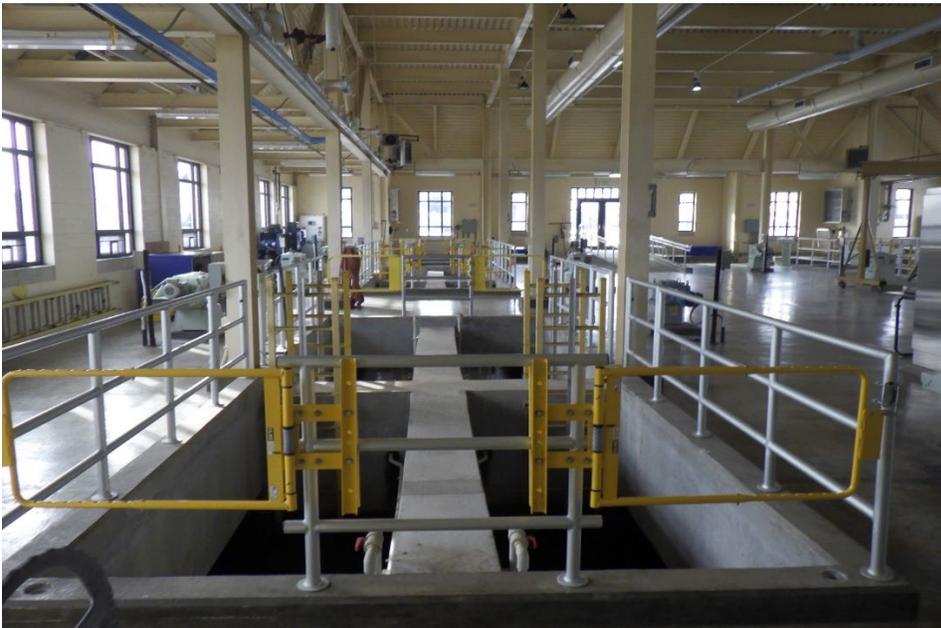
8: R0010093.JPG

Location: Racine Public Water System
Photographer: Amanda Cross
Date/Time: 2/19/2025 3:53 PM
Description: Pretreatment basin #1 overview photo. Basin capacity is 20 million gallons.

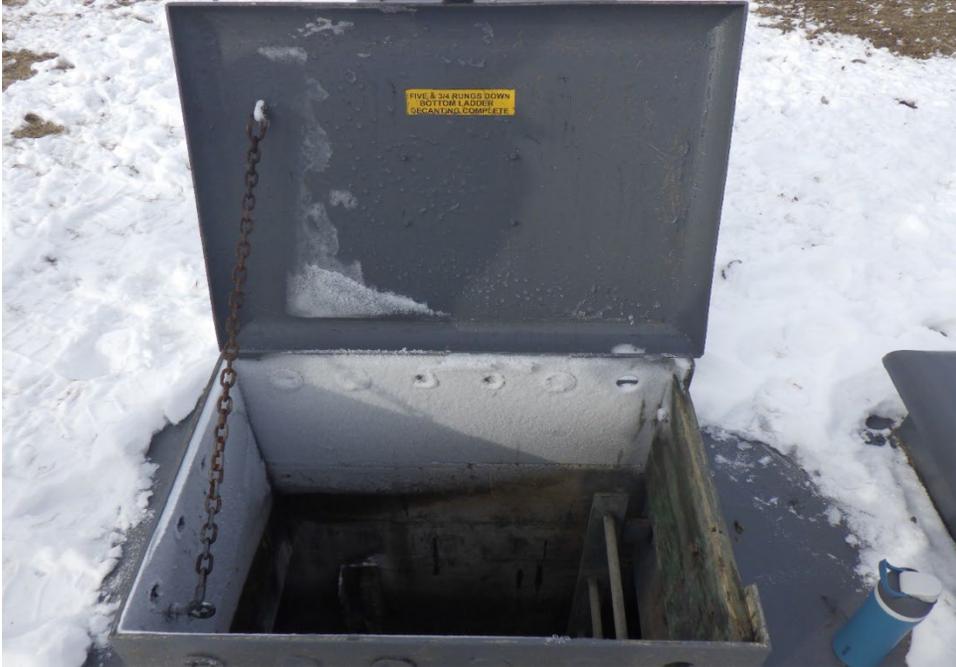
9: R0010094.JPG

Description: Basin #4, east end access hatch. Acces hatch is missing a gasket around the edge. Basin #4 contains raw water.

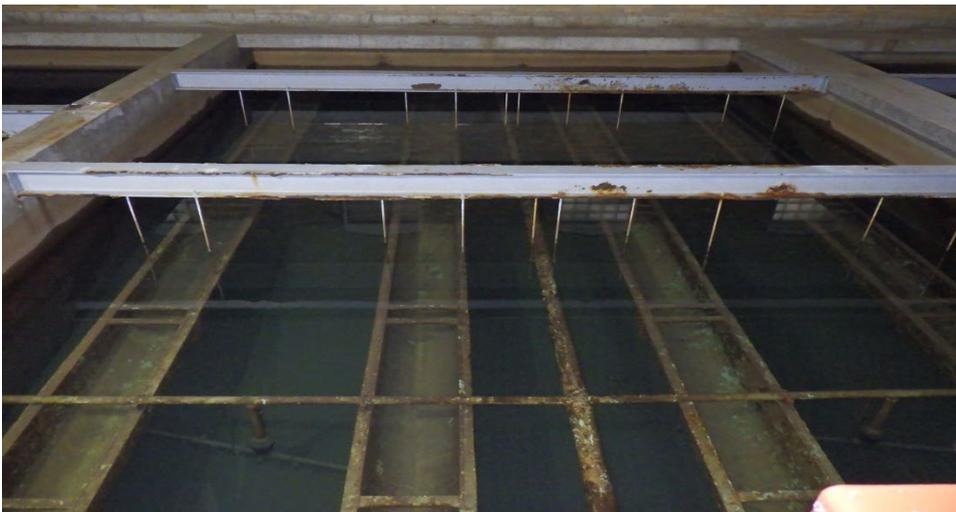
10: R0010095.JPG

Description: Filer #3 overview. Capacity is approximately 0.45 million gallons per day. The filter was operational at the time of the inspection.

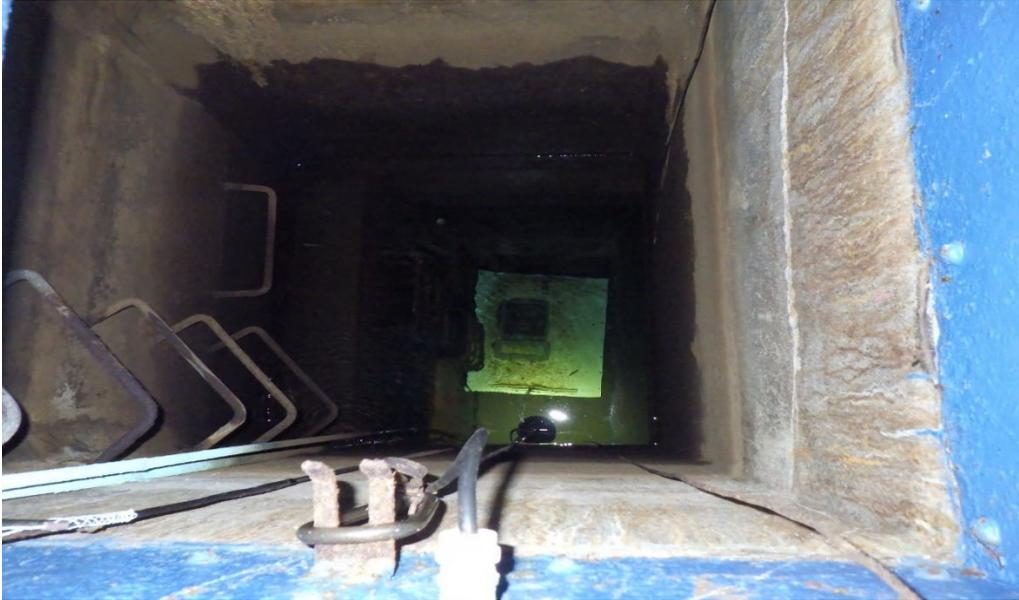
11: R0010096.JPG

Location: Racine Public Water System
Photographer: Amanda Cross
Date/Time: 2/19/2025 4:34 PM
Description: Clearwell #1 access hatch.

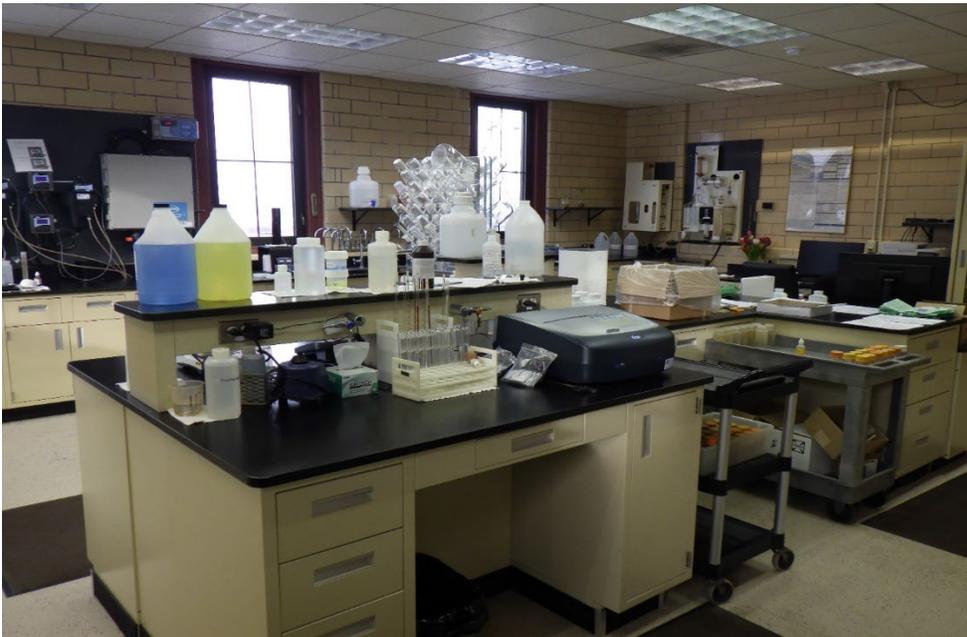
12: R0010097.JPG

Location: Racine Public Water System
Photographer: Amanda Cross
Date/Time: 2/19/2025 4:58 PM
Description: Plant laboratory overview.

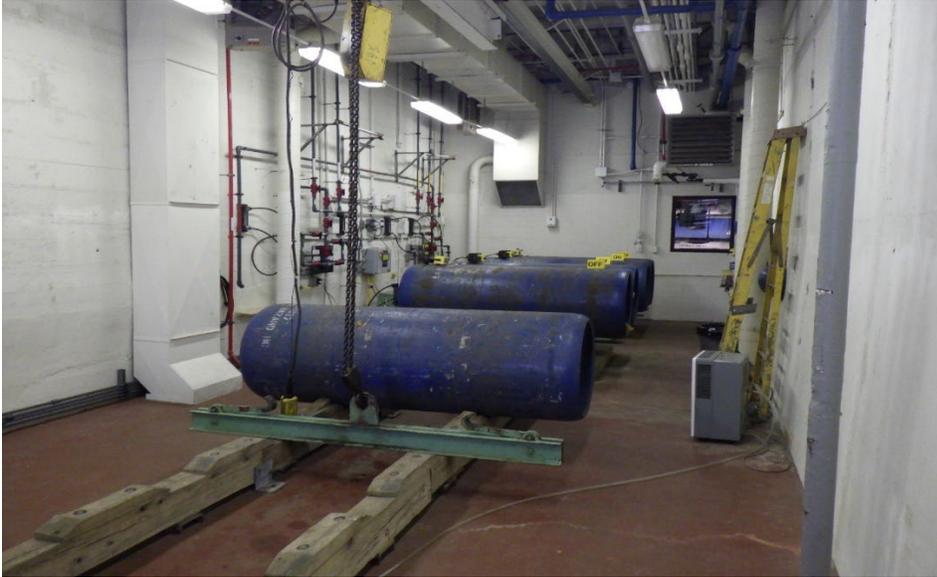
13: R0010098.JPG

Description: Overview photo of the chlorine bulk storage room. Feed equipment located on the left wall in the photo.

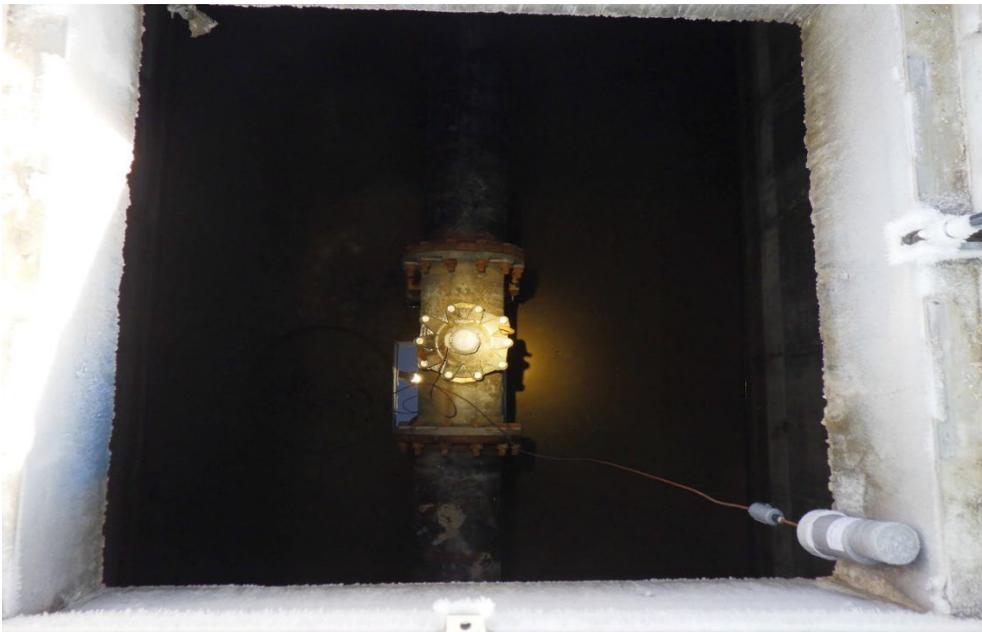
14: R0010099.JPG

Description: Charles Rd and 3-Mile Rd meter pit which is also the interconnect with Caledonia. Standing water was observed in the bottom of the pit.

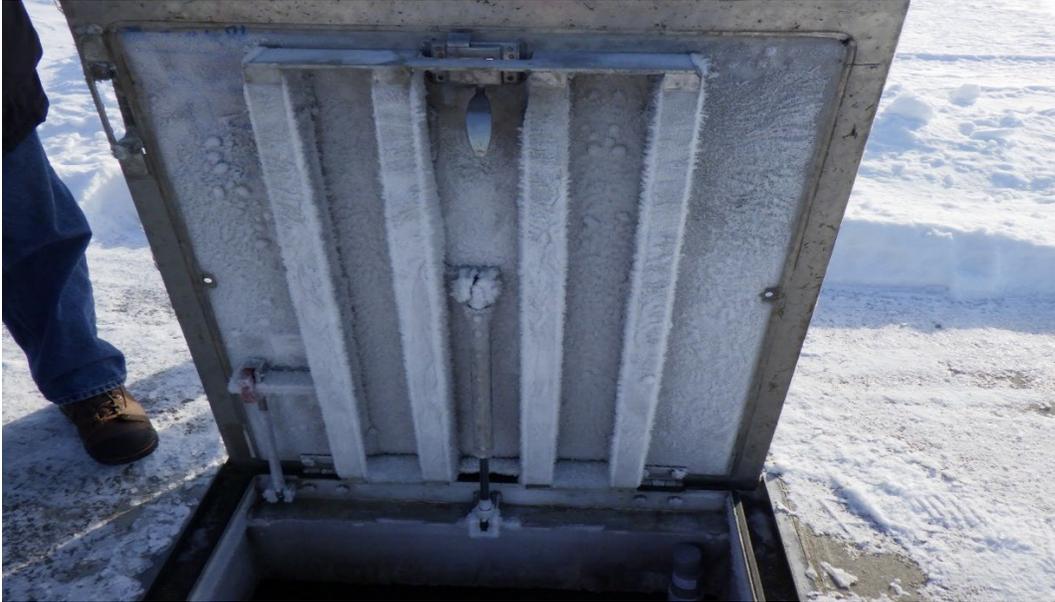
15: R0010100.JPG

Location: Racine Public Water System
Photographer: Amanda Cross
Date/Time: 2/20/2025 9:29 AM
Description: Caledonia meter pit hatch.

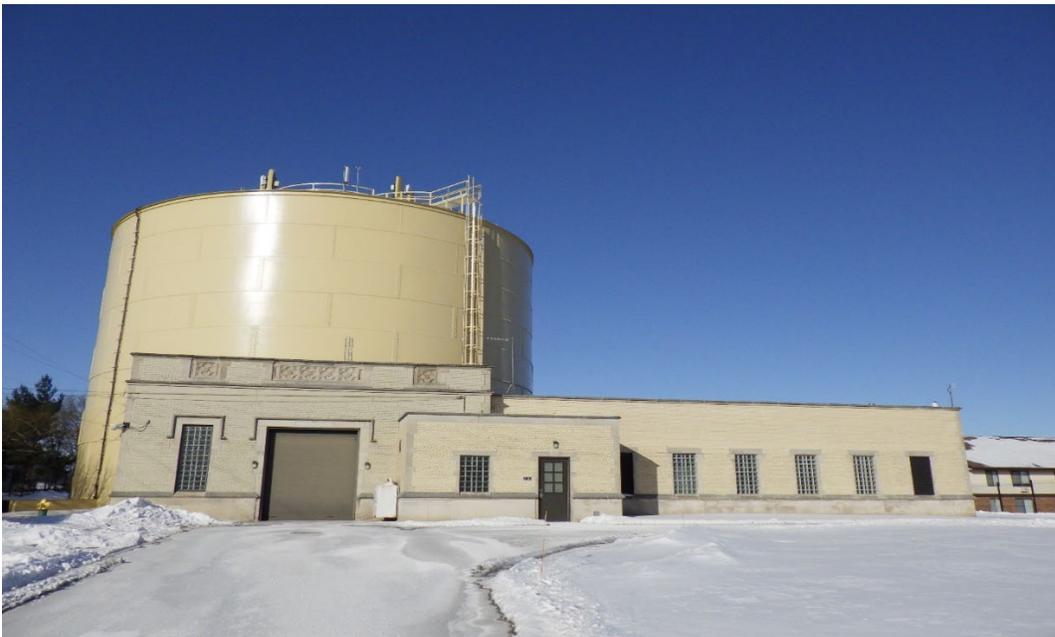
16: R0010101.JPG

Location: Racine Public Water System
Photographer: Amanda Cross
Date/Time: 2/20/2025 9:51 AM
Description: Parry Avenue booster pump station and tank.

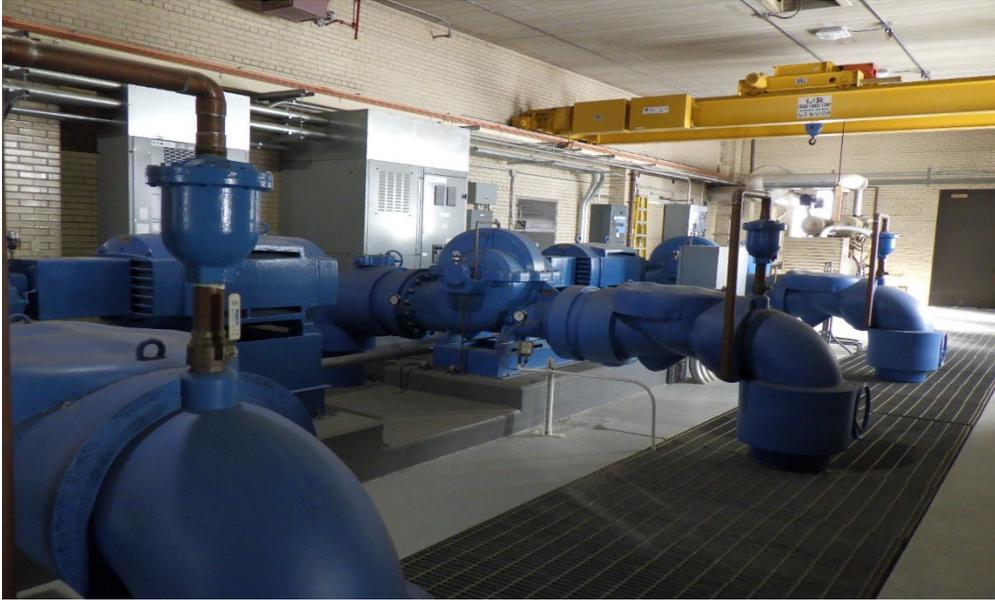
17: R0010102.JPG

Description: Overview photo of the inside of Parry Ave booster pump station. Pump #4 in the foreground and pumps #5 and #6 in the background.

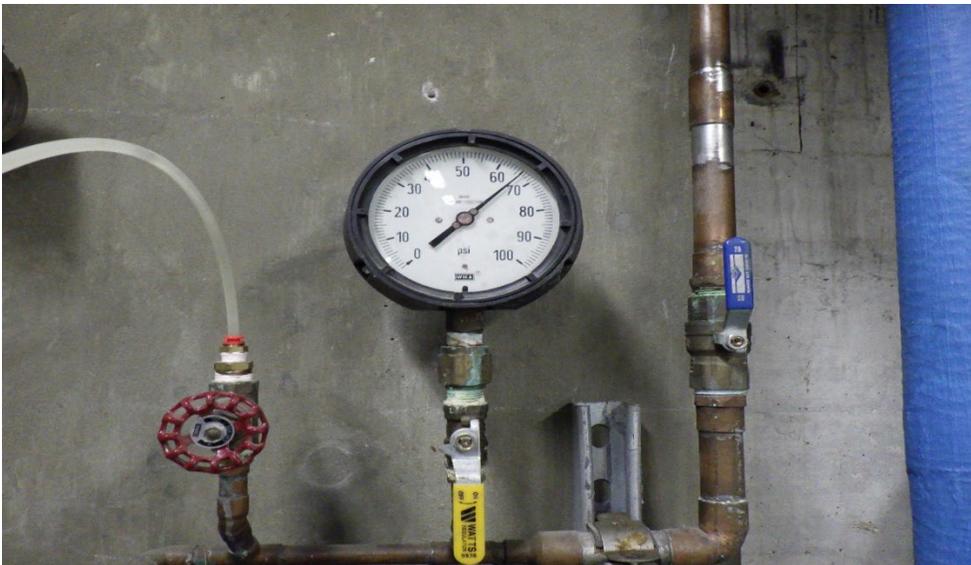
18: R0010103.JPG

Description: System pressure gauge in the Parry booster station basement.

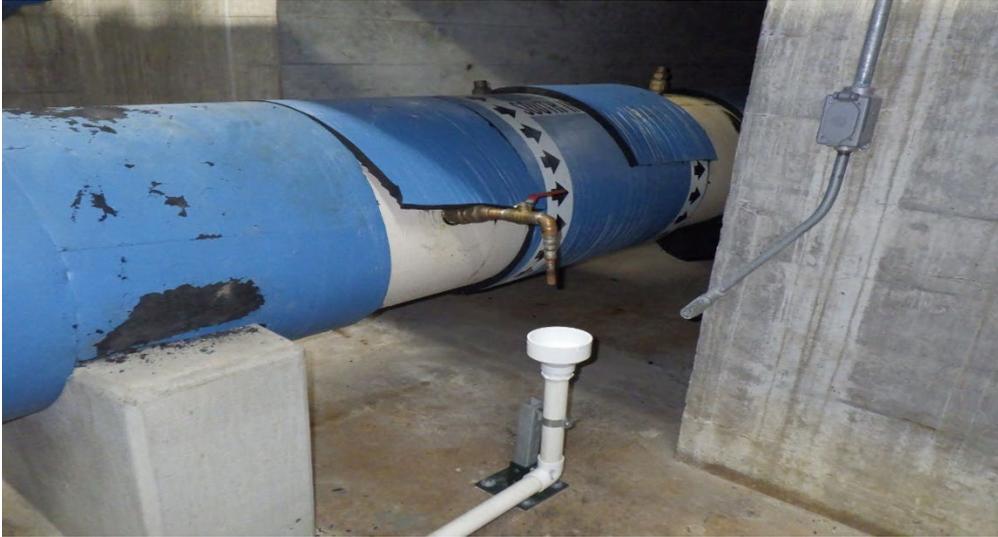
19: R0010104.JPG

Location: Racine Public Water System
Photographer: Amanda Cross
Date/Time: 2/20/2025 10:06 AM
Description: Sample tap in the Parry booster station basement.

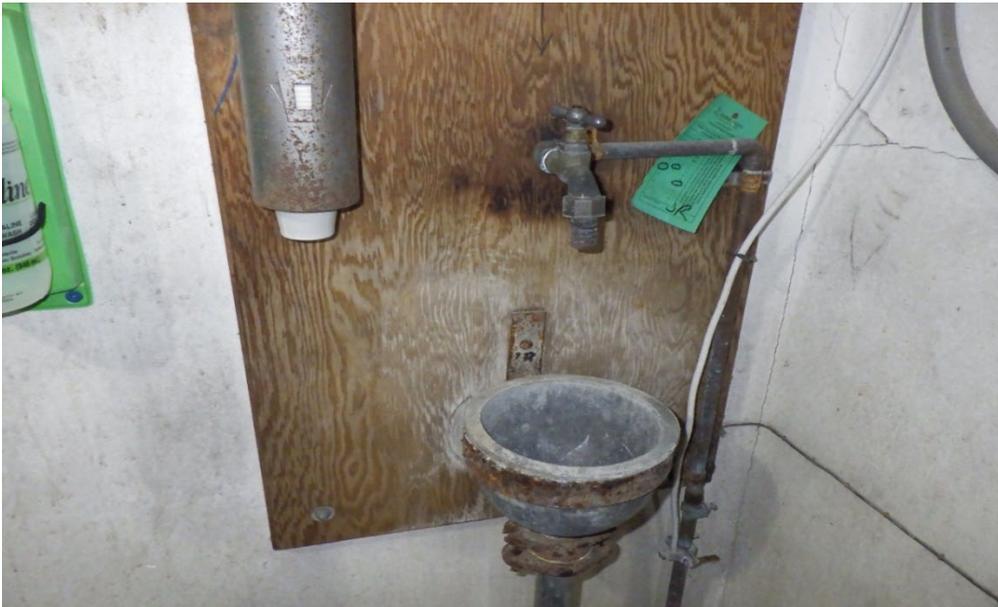
20: R0010105.JPG

Photo(s): Appendix A Photo 16-19	
Reference #: OB-020	AOC: Yes
The sample tap for the Coolidge Avenue tank effluent had a threaded connection, representing a potential cross connection.	
<i>Citation: NR 811.64(16)(a): Storage facilities shall have a smooth-end sampling faucet installed in the connecting main or riser pipes of elevated tanks, standpipes, and reservoirs, if design permits.</i>	
Photo(s): Appendix A Photo 20

Location: Racine Public Water System
Photographer: Amanda Cross
Date/Time: 2/20/2025 10:24 AM
Description: Coolidge Tower sample tap with visible threads
