Fire Station 6 Space and Operational Issues

City of Racine
Fire Department - Fire Station 6
 Space Needs Program

SECTION 5.6
FIRE STATION NO. 6
EXISTING BUILDING PLANS

**SECTION 5.6
FIRE STATION NO. 6 -
EXISTING CONDITION
ANALYSIS**

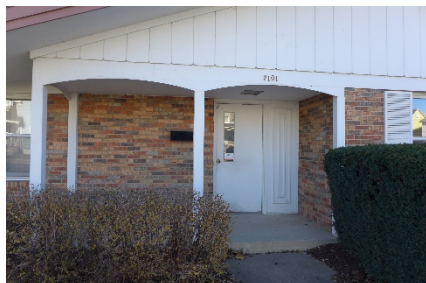
No accessible access to front door

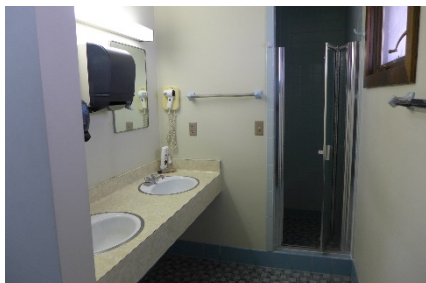
Inaccessible shower stall and accessories

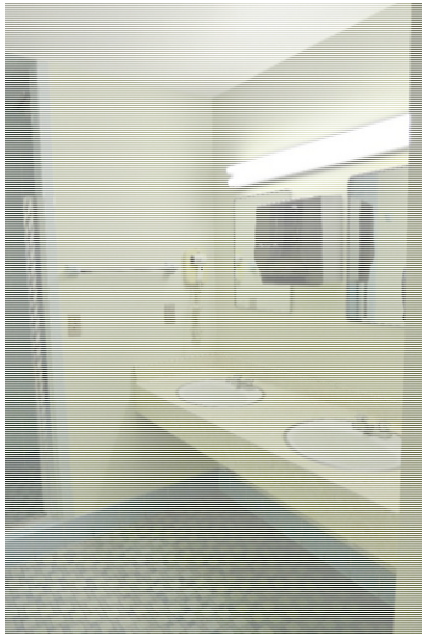
Station has one primary multi-user restroom to serve all firefighters.

Overall not many building code violations were observed during the building assessment review. The major violation is the lack of separated toilet rooms for women and men. Currently there is one large restroom with 2 toilets, 2 showers and 4 sinks. The building code requires separate facilities be provided for each sex.

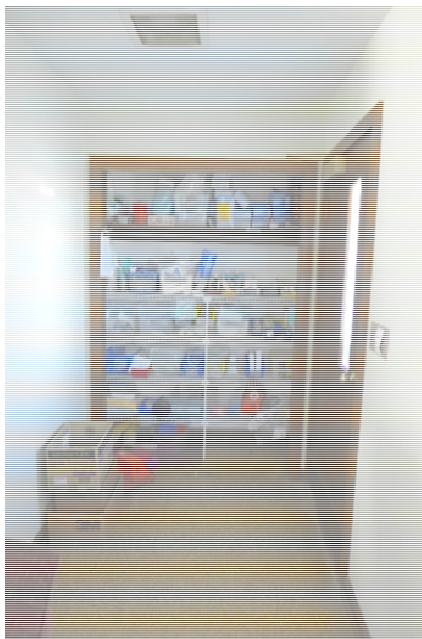
Lack of security for EMS supplies

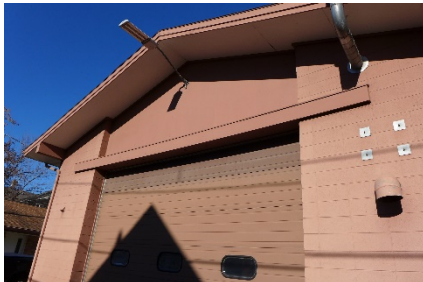
Sagging beam at overhead door

- The main support above the overhead bay doors appears to be sagging
- The concrete apron at the front of the apparatus bay has major cracking and spalling.

City of Racine – Fire Station No 6		Type of Item	Priority of Item	Estimated Impact
Item/ Issue	1, 2, 3, 4, 5	a, b, c		
18	Main support lintel over the apparatus bay overhead door is sagging from deflection and should be replaced/ reinforced.	4	b	\$4,000 - \$15,000
19	Repair/ replace major cracks in front bay apron	4	b	\$25,000 - \$35,000
20	Address spalling of masonry and mortar on apparatus bay walls from moisture infiltration and damage	4	b	\$50,000 - \$100,000
21	Replace rear entry door to house that is delaminating	5	b	\$3,000 - \$5,000
22	Increase bay clearance height to meet DOT 13'-10"	1/5	b	\$40,000 - \$50,000
23	Water concerns around building that has caused issues with water in basement, and currently being directed at neighbor	5	b	\$2,000 - \$25,000
24	Repair/ replace rear parking and apron surfaces	5	b	\$20,000 - \$30,000
25	Floor structure is undersized for the live-loads of the current operation and use. Facility not intended to meet essential facility requirements	1/4	b	\$40,000 - TBD

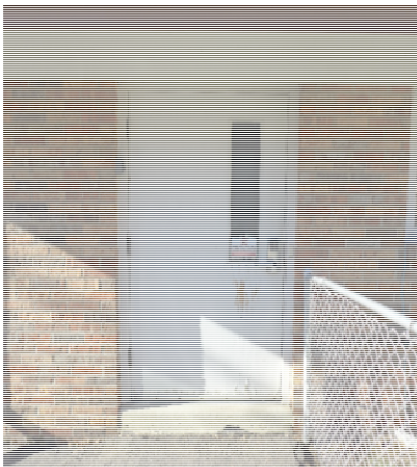
Delamination of back door

- The CMU walls on the east side of the building appear to be spalling due to moisture infiltration into the block.
- The rear entry door is made of wood and has begun delaminating after years of exposure to the elements with little maintenance.

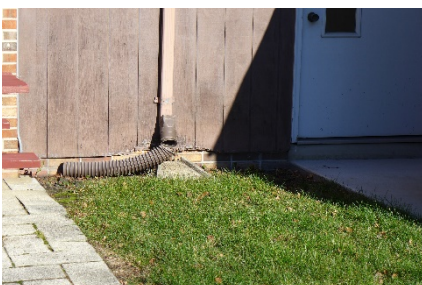
Broken downspout allowing water to collect near foundation wall.

- Many downspouts were noted to have added drain pipes to them to direct the water further away from the building. At some locations the downspouts have broken and allow water to discharge directly at the foundation wall.

- Several areas of water leakage were noted in the basement, most likely caused by water pooling at the exterior foundation wall and seeping in.
- The original floor structure is residential grade and was not designed to withstand the live loads that are required of commercial buildings.

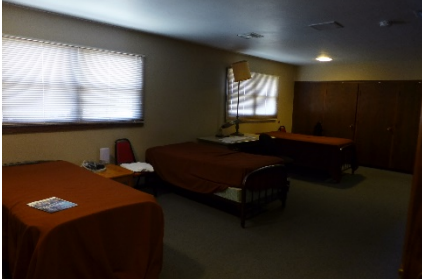
Lack of lighting within bunk area

- All finished within the occupied spaces are residential grade and beyond their useful life.
- There is a lack of adequate lighting throughout the station. Small residential lamps are being used as supplemental lights in several areas.
- The kitchen cabinets and appliances are residential grade. It is not recommended using residential ranges and cabinets in fire stations due to the heavy wear and tear that occurs with multiple people using the space on a daily basis.
- **There is no mechanical air exchange within the building.**

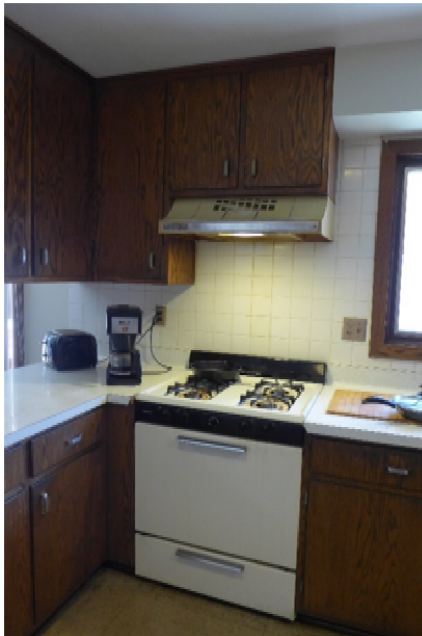
Residential grade appliances and cabinets within kitchen

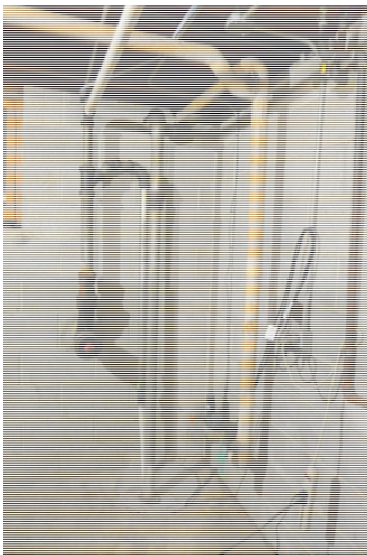
PVC and cast-iron waste piping

There were no reported issues with the domestic water or waste piping from the station personnel, however, most fixtures are older, and likely in need of up-dating and replacing. Some waste piping in the basement had been replaced from cast-iron to PVC plastic. It was not apparent whether this was due to deterioration or renovation.

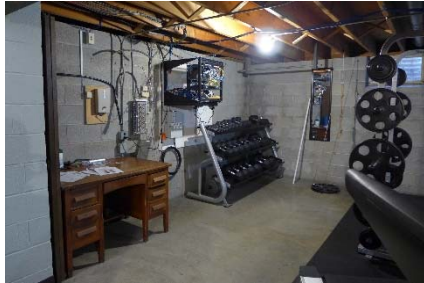
Original Main Service

The existing electrical service appears to be a basic 225-amp, 240-volt, single phase, three wire residential style service with a ct/meter on the outside of the building which feeds a main disconnect switch located in the apparatus bay panelboard. The electrical service appears to be original and in overall poor condition.

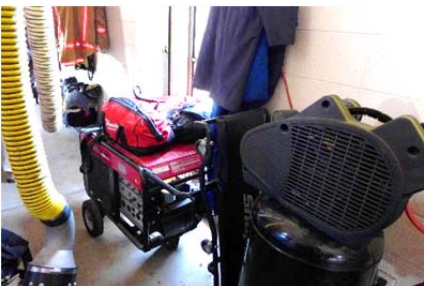
Portable Generator

There is no permanently installed generator set installed. The 6500-watt portable generator appears to be older and in somewhat poor condition overall. There is a 30-amp 240-volt single phase, three wire manual transfer switch in the apparatus which supplies limited loads within the facility. In terms of back-up capacity maybe minimal communications and lighting and an overhead door could be powered from the back-up available.

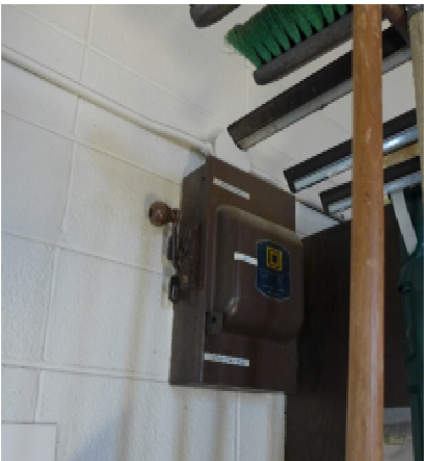
Transfer switch

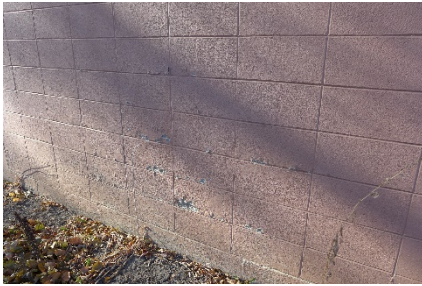
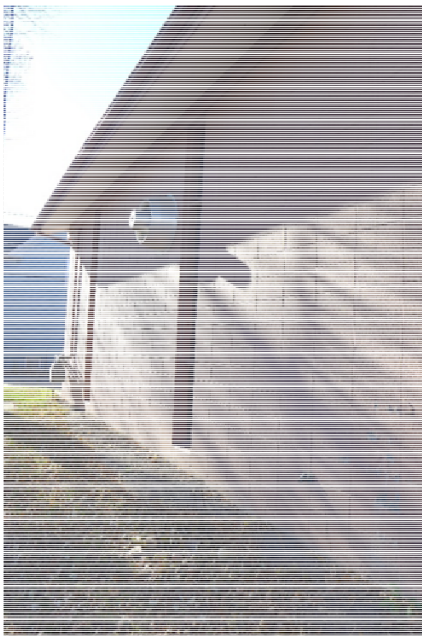
Spalling CMU walls at App. Bay

The exterior appeared in variable condition. Small areas of spalling at the stack-bond CMU were observed around the apparatus bay. The spalls appear to be at locations which were previously patched. Additionally, there is a vertical crack in the stack-bond joint at the northwest corner of the apparatus bay. This crack has translated through to the interior.

The causation of the spalls should be determined. It is our opinion that the previous patches have failed and are reoccurring. The spalled masonry and failed patches should be reviewed periodically and patched effectively as part of a future exterior repair project.

Station 6 was generally in fair condition. We recommend the vertical crack at the CMU head joint be repointed to prevent water infiltration. Water infiltration can cause additional masonry distress including efflorescence, reinforcement corrosion and subsequent CMU cracking and/or spalling. The effects of freeze-thaw can accelerate this damage.
