Office of the City Engineer

October 2, 2017

MEMO

Re: Traffic Study - Intersection Analysis of Maria St and Westwood Drive

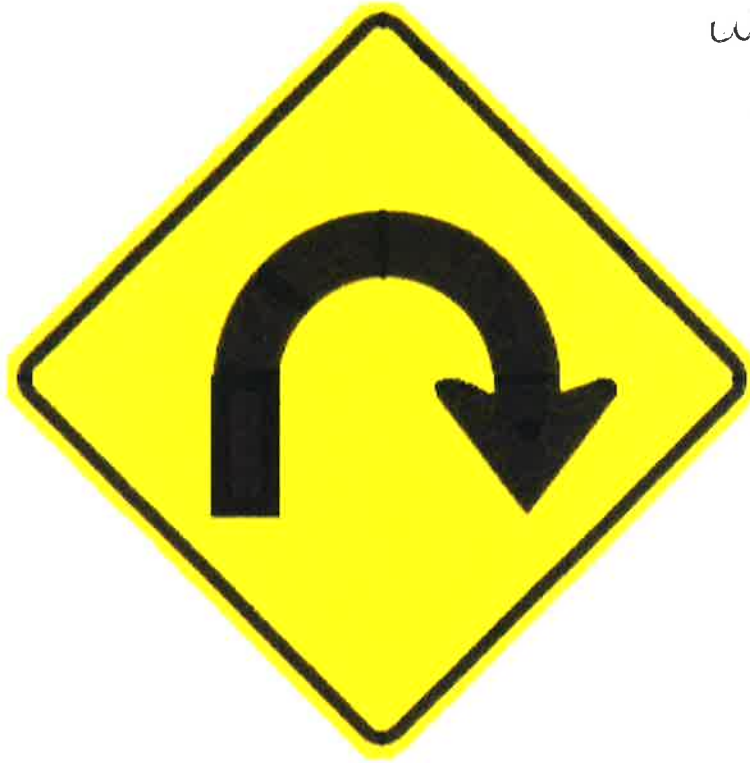
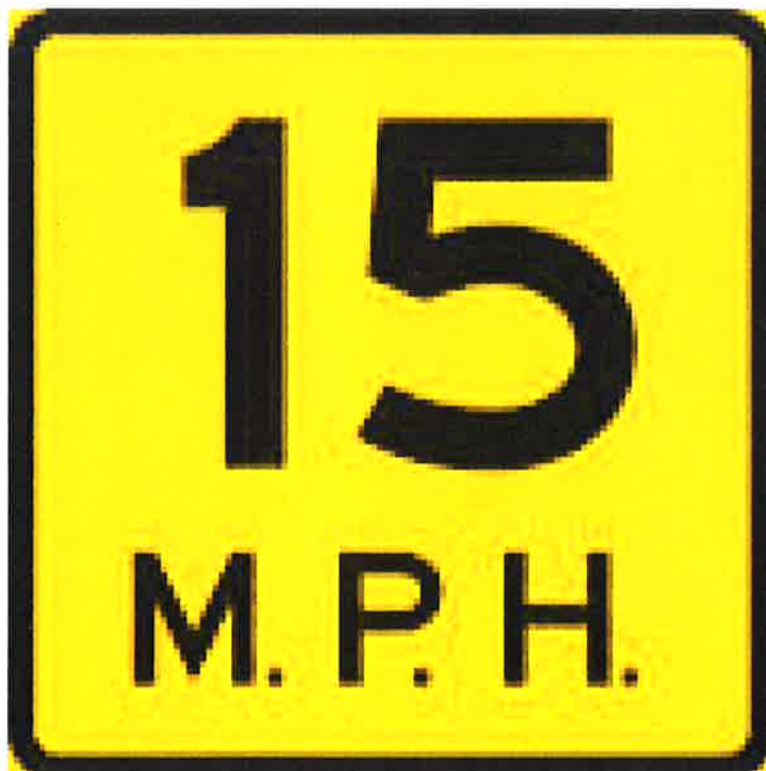
W1-11
(30x30)

W13-1P
15 MPH
(12x12)

- It is my opinion to leave the intersection “As-Is”. This intersection is exactly the definition of an ‘Uncontrolled’ intersection.
- Just to the west of the intersection the addition of a warning sign W1-11 (30”x30”) with a cautionary speed of 15 MPH W13-1P (12”x12”) – see attached
