CLAD + PAINT EXISTING ~~ROOF~~ ROOF ACCESS STAIR

613 Sixth Street RACINE

**Rooftop Stair Enclosure Cladding and Color Proposal**

ROOFTOP STAIR HUT CLADDING

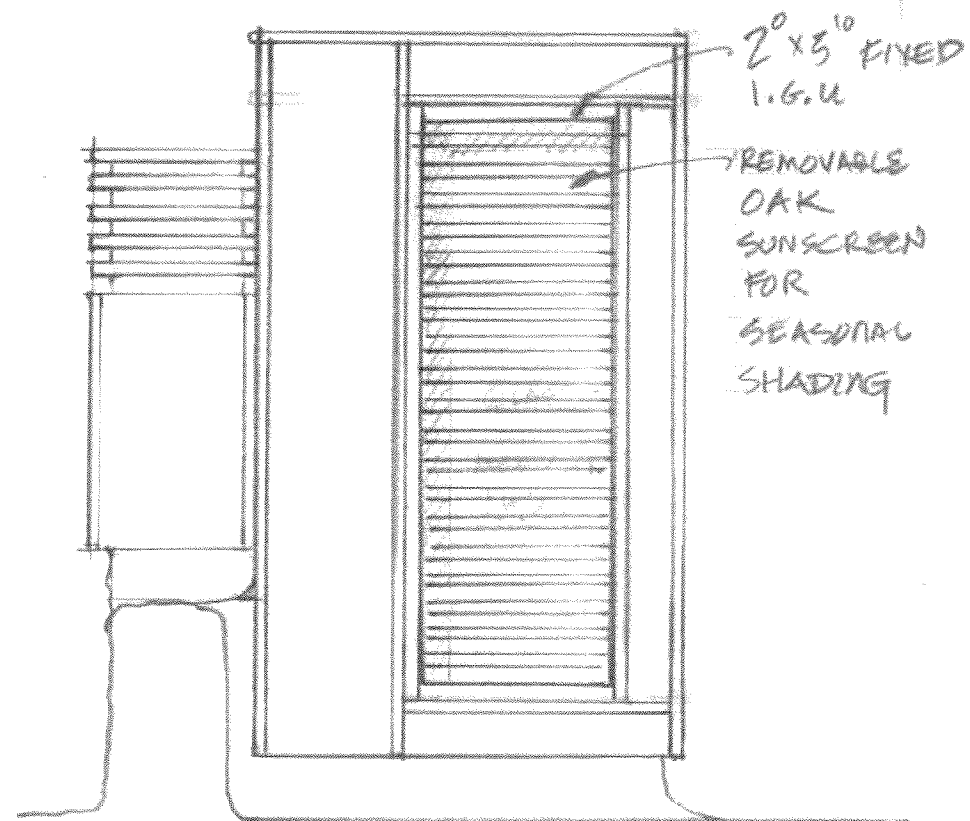
SOUTH EL. - 1/2" = 1'-0"

SCREEN DOOR IS CONCEALED BEHIND ATTACHED CLADDING MEANT TO RELATE ITS PROPORTIONS TO THE SOUTH WINDOW + ADJACENT WALL  
OAK SCREEN ALLOWS FOR VENTILATION WITH DOOR OPEN TO INSIDE

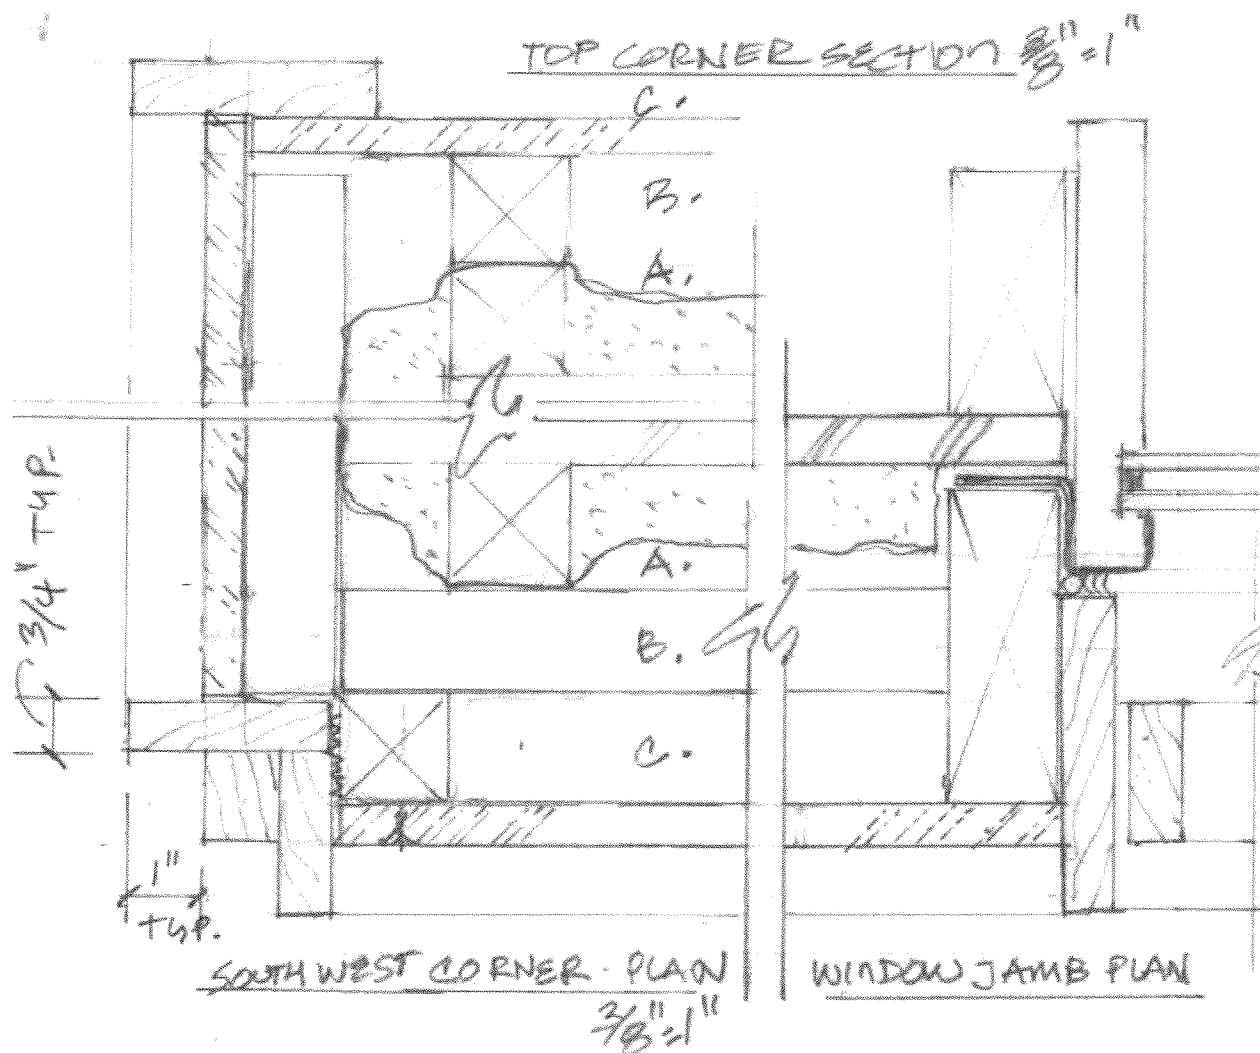
TOP CORNER SECTION 3/8" = 1"

RAIN SCREEN CLADDING  
HARDIE PANEL / WOOD TRIM EMULATING STANDING SEAM METAL.

A. EXISTING FURRING EMBEDDED IN FOAM ROOFING - DRAINAGE PLANE  
B. NEW FIRRING AS NEEDED TO TRUE SURFACES + CREATE 1" MIN. CAVITY

C. CLADDING + TRIM - TRIM PRE-ATTACHED WHERE POSS. ON SOUTH FACE A SECOND FIRRING LAYER IS ATTACHED TO PANELS TO PROVIDE ANCHORING FOR TRIM AND TO DEEPEN WINDOW. ALL PANEL EDGES SEALED BEFORE FINAL ASSEMBLY.

From a durability perspective, this method of building allows the panels to be cut, edge primed and details applied and painted before they are attached to the structure as a rain screen cladding system.

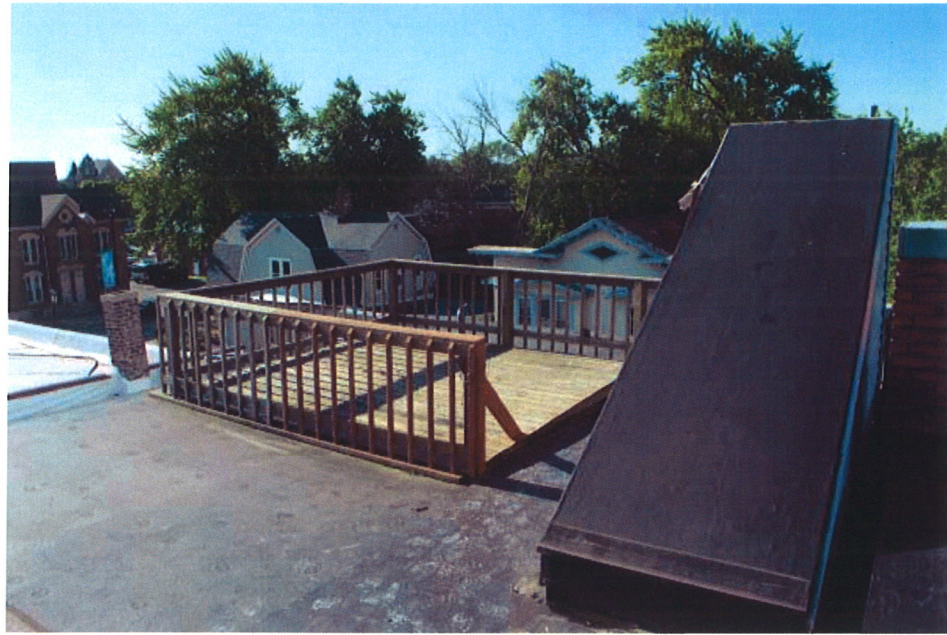
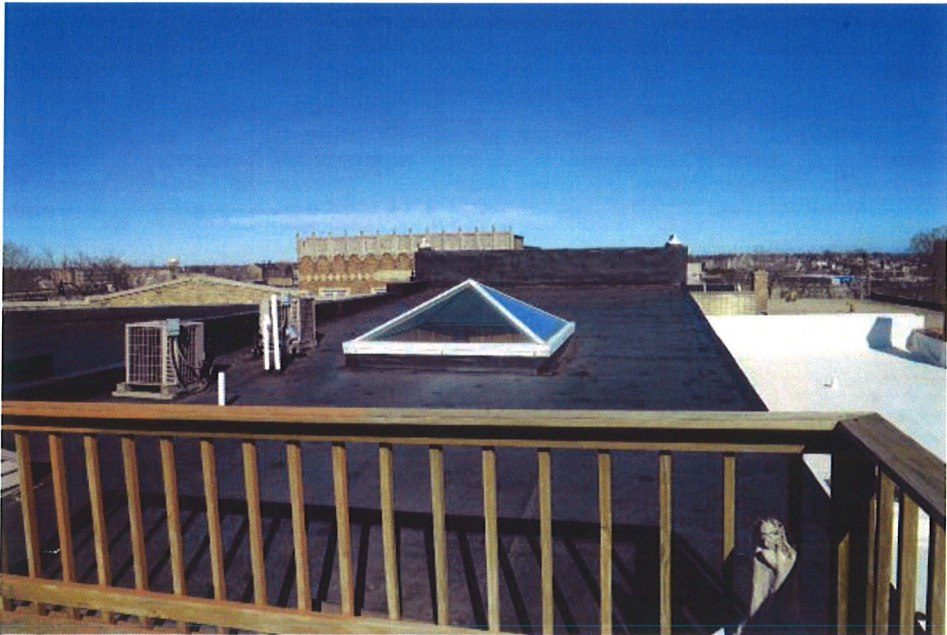
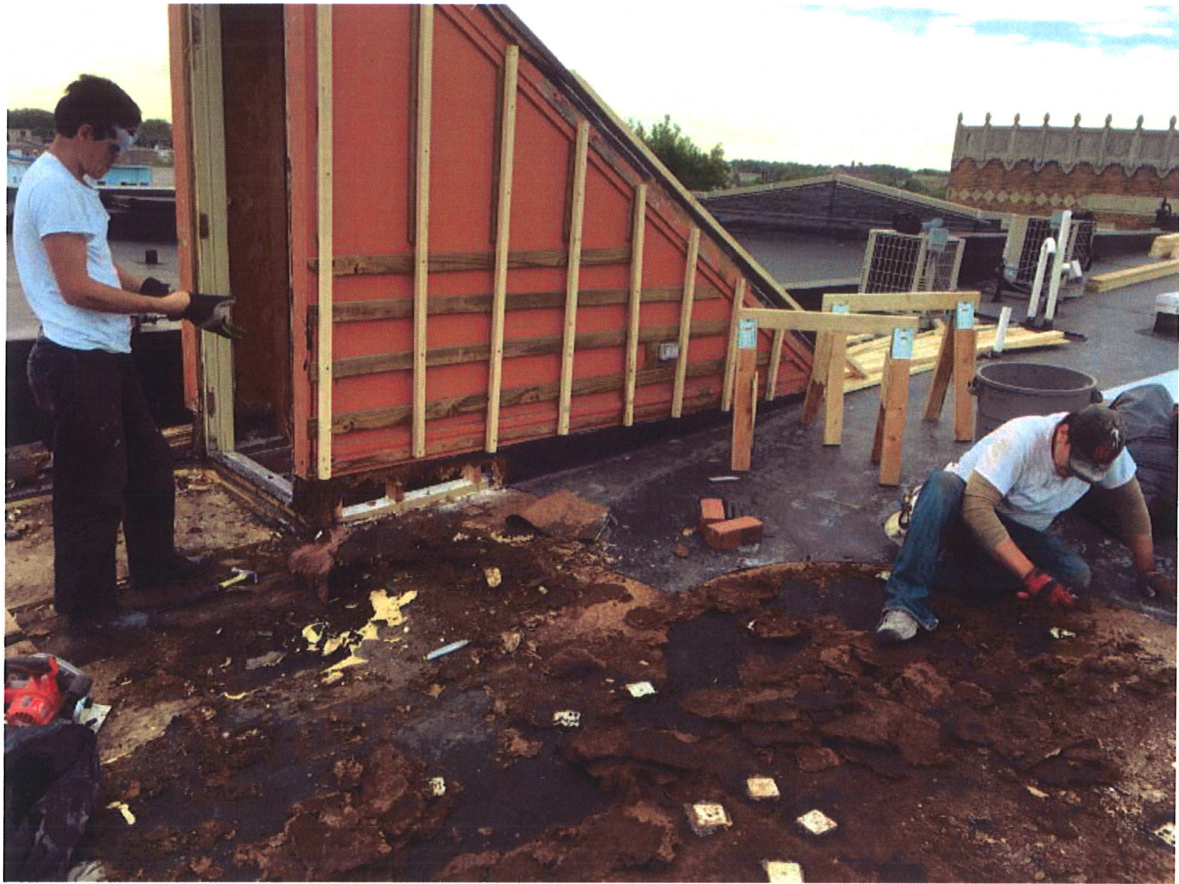
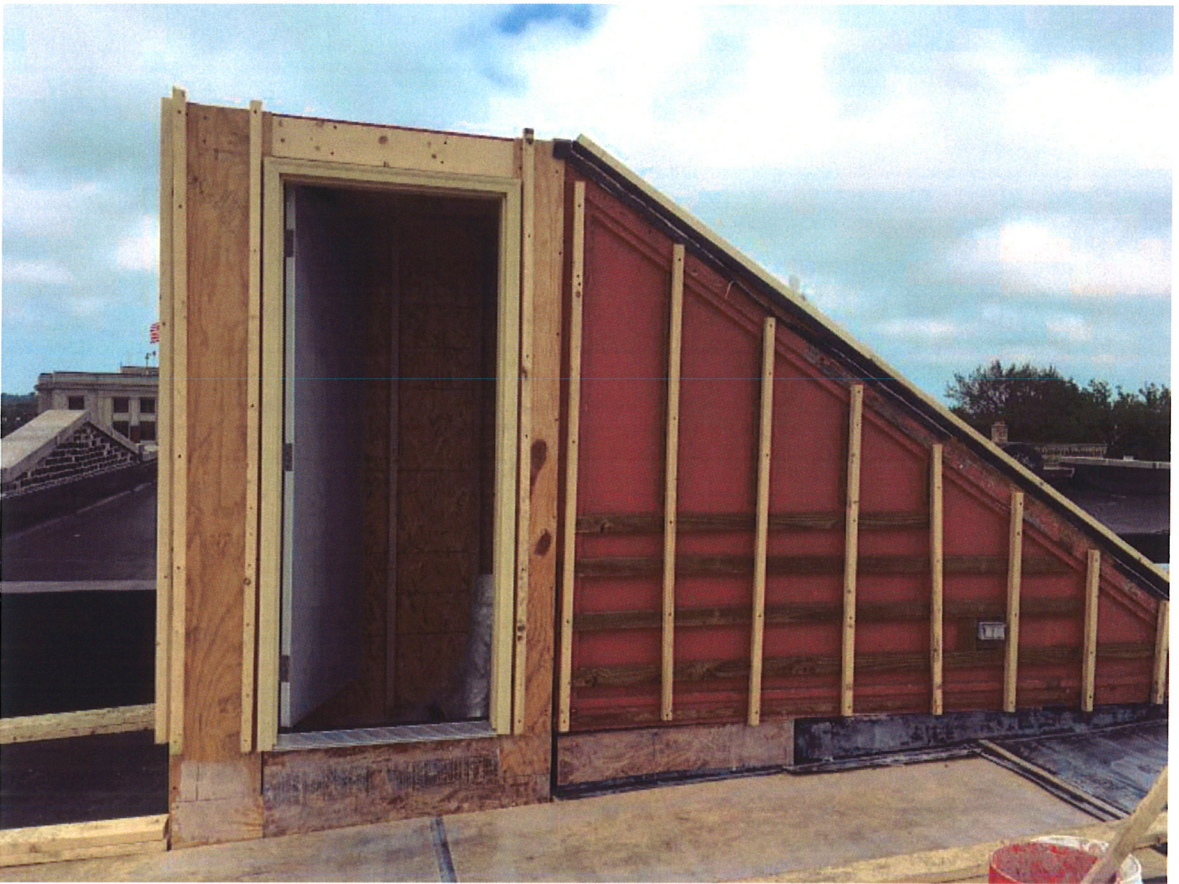
Before the current renovation, the rooftop access stair was a structure clad in beige aluminum siding. A pressure treated wood deck surrounded it on the south and east. Beneith the aluminum siding the structure was revealed to have originally been painted the same terra-cotta color found on the south elevation trim.

The building had been re-roofed with an EDPM roof above 2" of isocyanurate insulation and fiber board in 1990. The stair opened onto the roof without a landing, and it did so almost flush to the roof, a poor detail that had caused the roof to fail and saturate a large area of the 1990 roofing and insulation. The deck was also poorly detailed and had also contributed to the unexpectedly bad conditions found durring our efforts to prep the roof for the current application of an additional 3" of high density foam/ silacon roofing.

The upshot was that we decided on the fly to extend the stair access hut in order to both lift the door an additional 8" above the roof and to create a legitimate landing at the top of the stair. Vertical furring strips were added so that they would be integral to the foam coating that has now become the drainage plane.

Stair hut and damaged roofing

Stair hut extended to create a landing and raise the door for adequate flashing

As shown in the attached photographs, the stair enclosure was altered in the course of our own insulation and reroofing project in response to problems that we found in prepping for the new roof. The roof membrane around the stair had failed due to poor detailing- the stair exited to the roof without a landing and without adequate clearance from the roof for a proper termination detail. Simultaneously, the deck's poor attachment detailing and lack of adequate clearance was found to have caused similar problems and a large portion of insulation and protection board under the existing EPDM roof was saturated with water and needed to be removed. We added an additional step and a proper landing to the stair and moved the door from the front to the side to keep the overall movement path the same. Provisions were made for the addition of an aperture on the south elevation but there was not time before the insulation/ roofing was applied to install a window unit. Provisions were also made to attach an unspecified cladding system through the anchoring of vertical furring strips which are now embedded within the insulation/roofing. The new roof system consists of 3" – 4.5" of high density foam and a liquid applied silicon coating, bringing the roof to current energy efficiency standards.

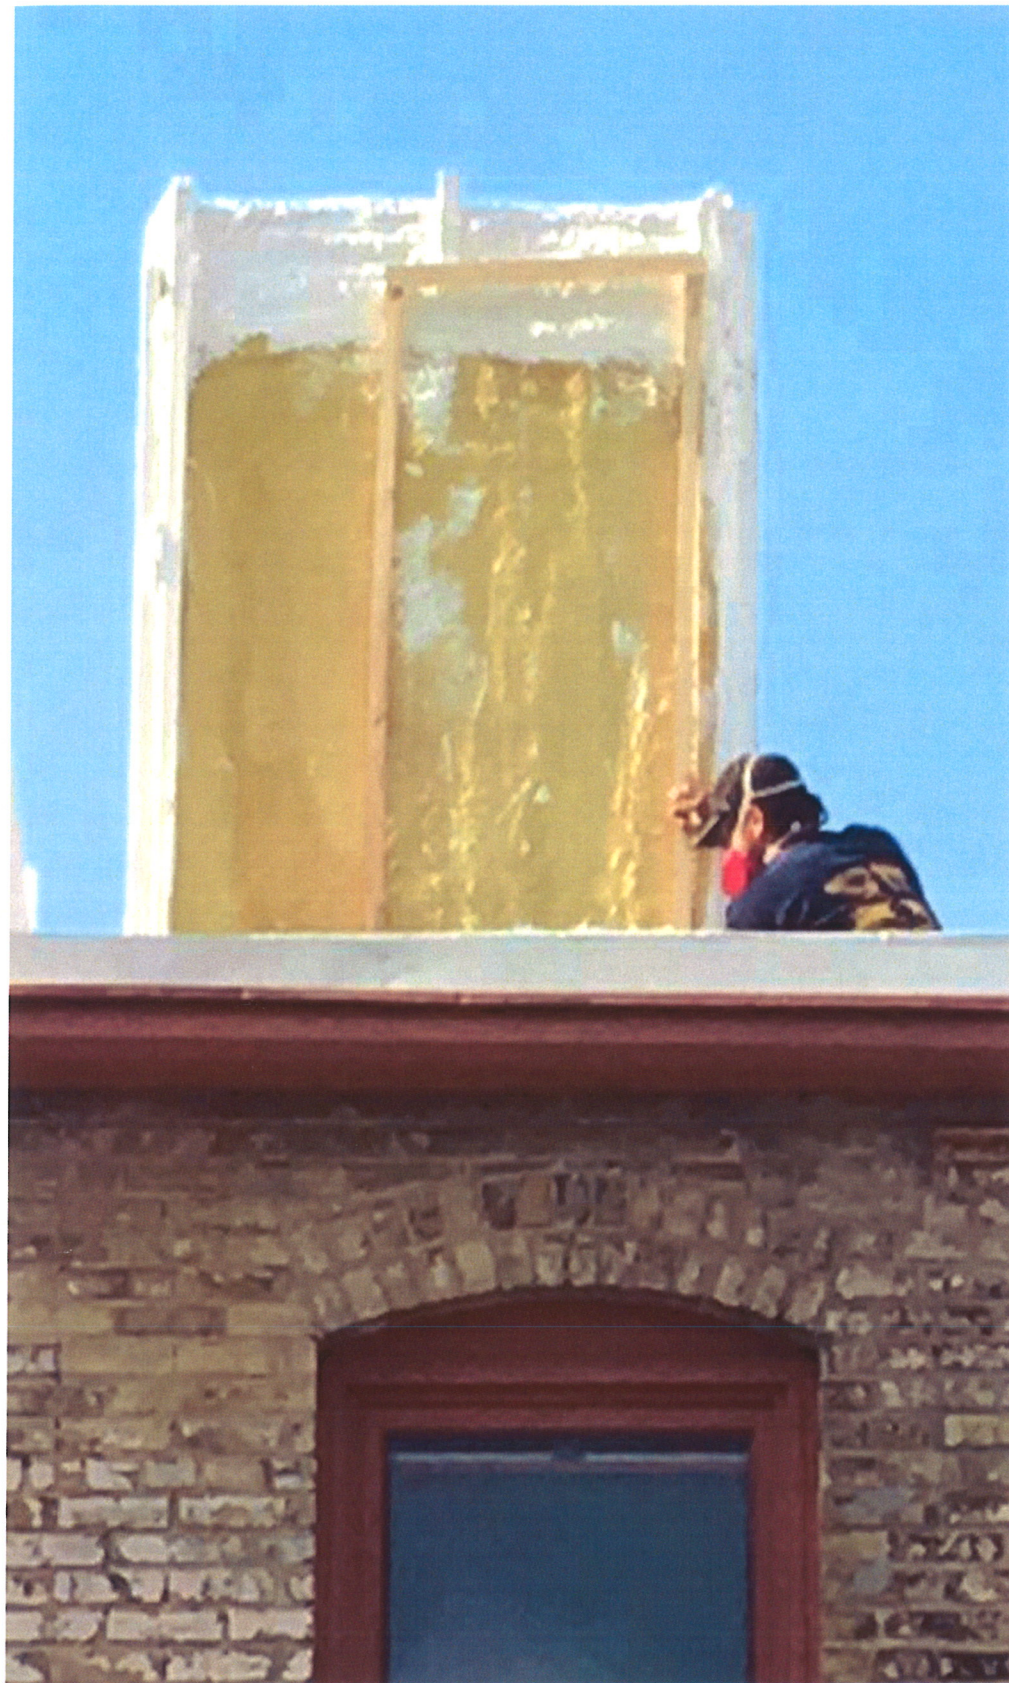
Two colors were originally considered- the same terra cotta as found on the south facade and a warm gray (shown in this study). A third gray/ beige is modelled in other photographs and is our current choice for a color to blend in with the old cream city brick.

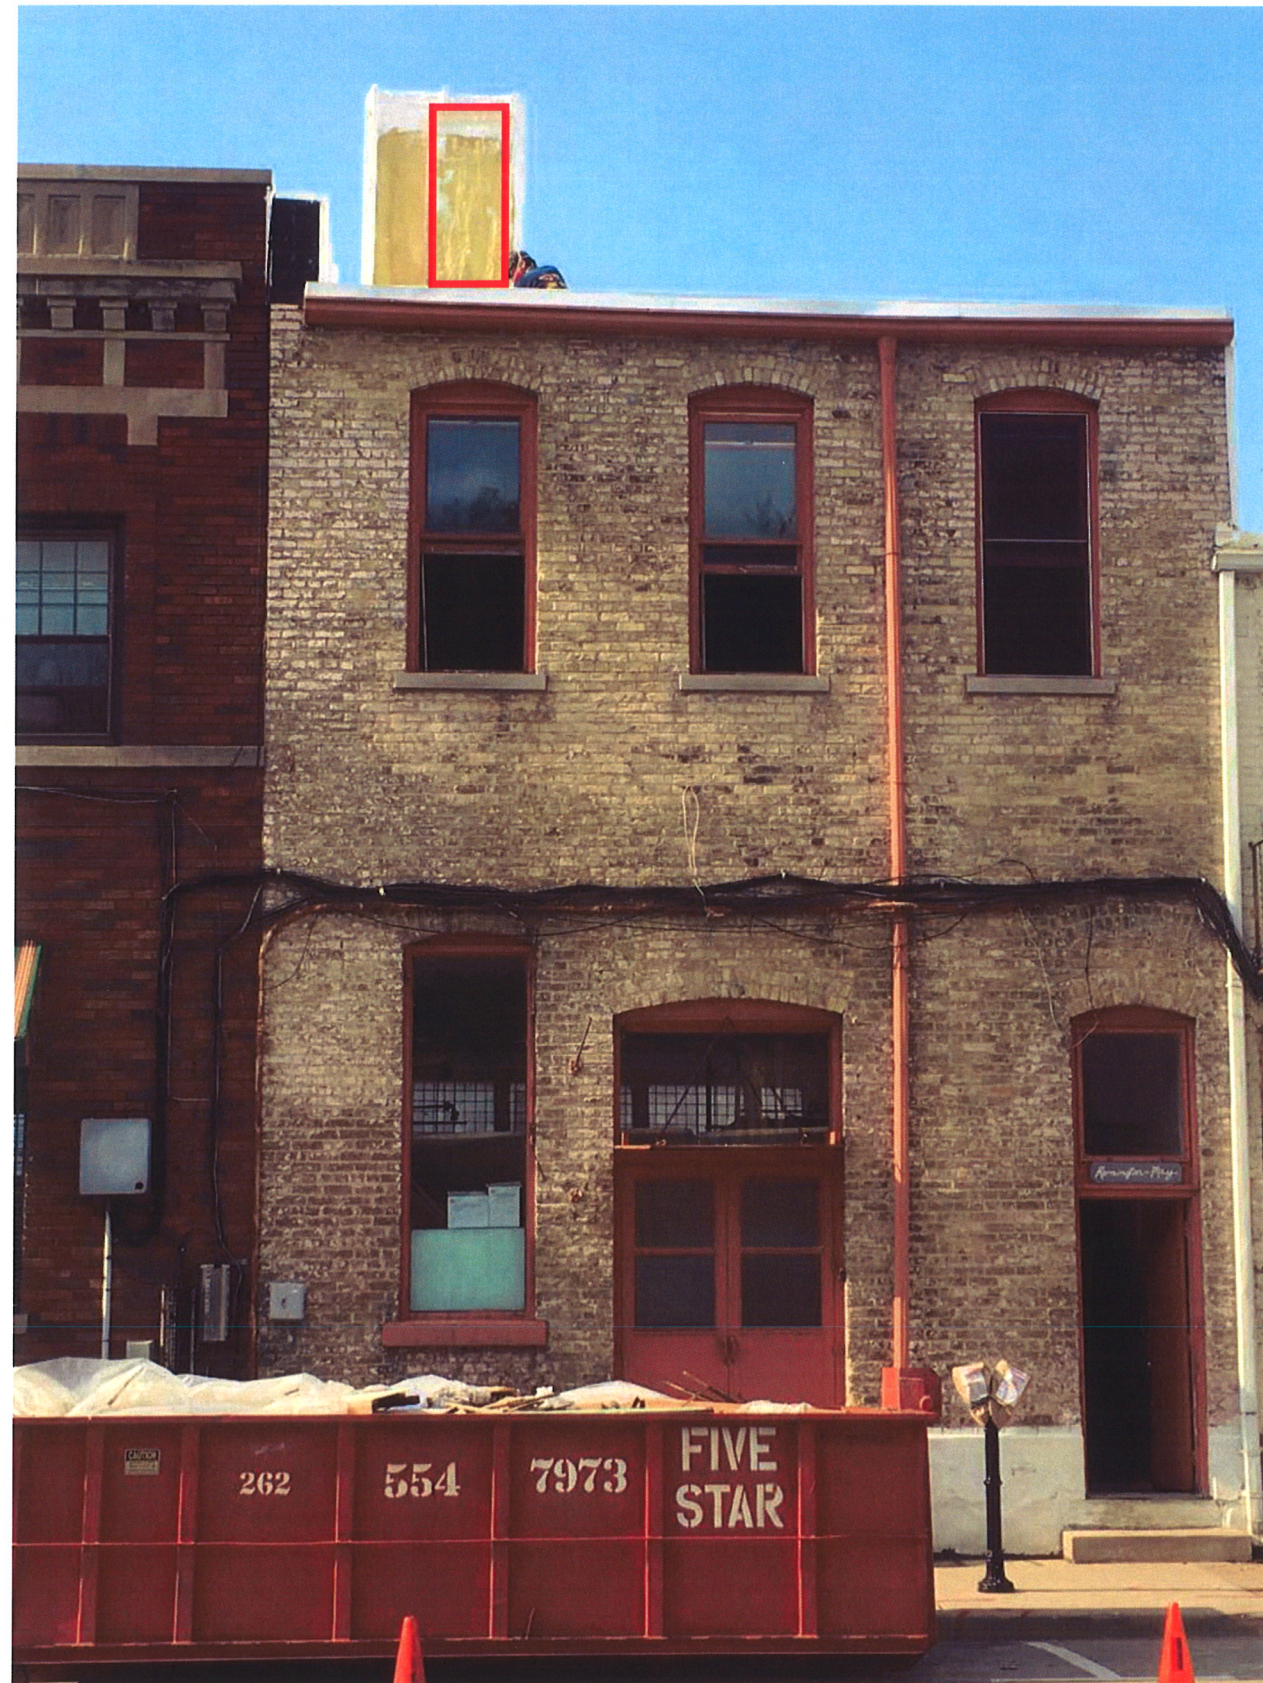
This study mocks up the positioning of a fixed glass aperture to relate to the south facade. At 2' x 5'-10", the window is modelled on the second floor windows in size and proportion and as close to centered above them as possible.

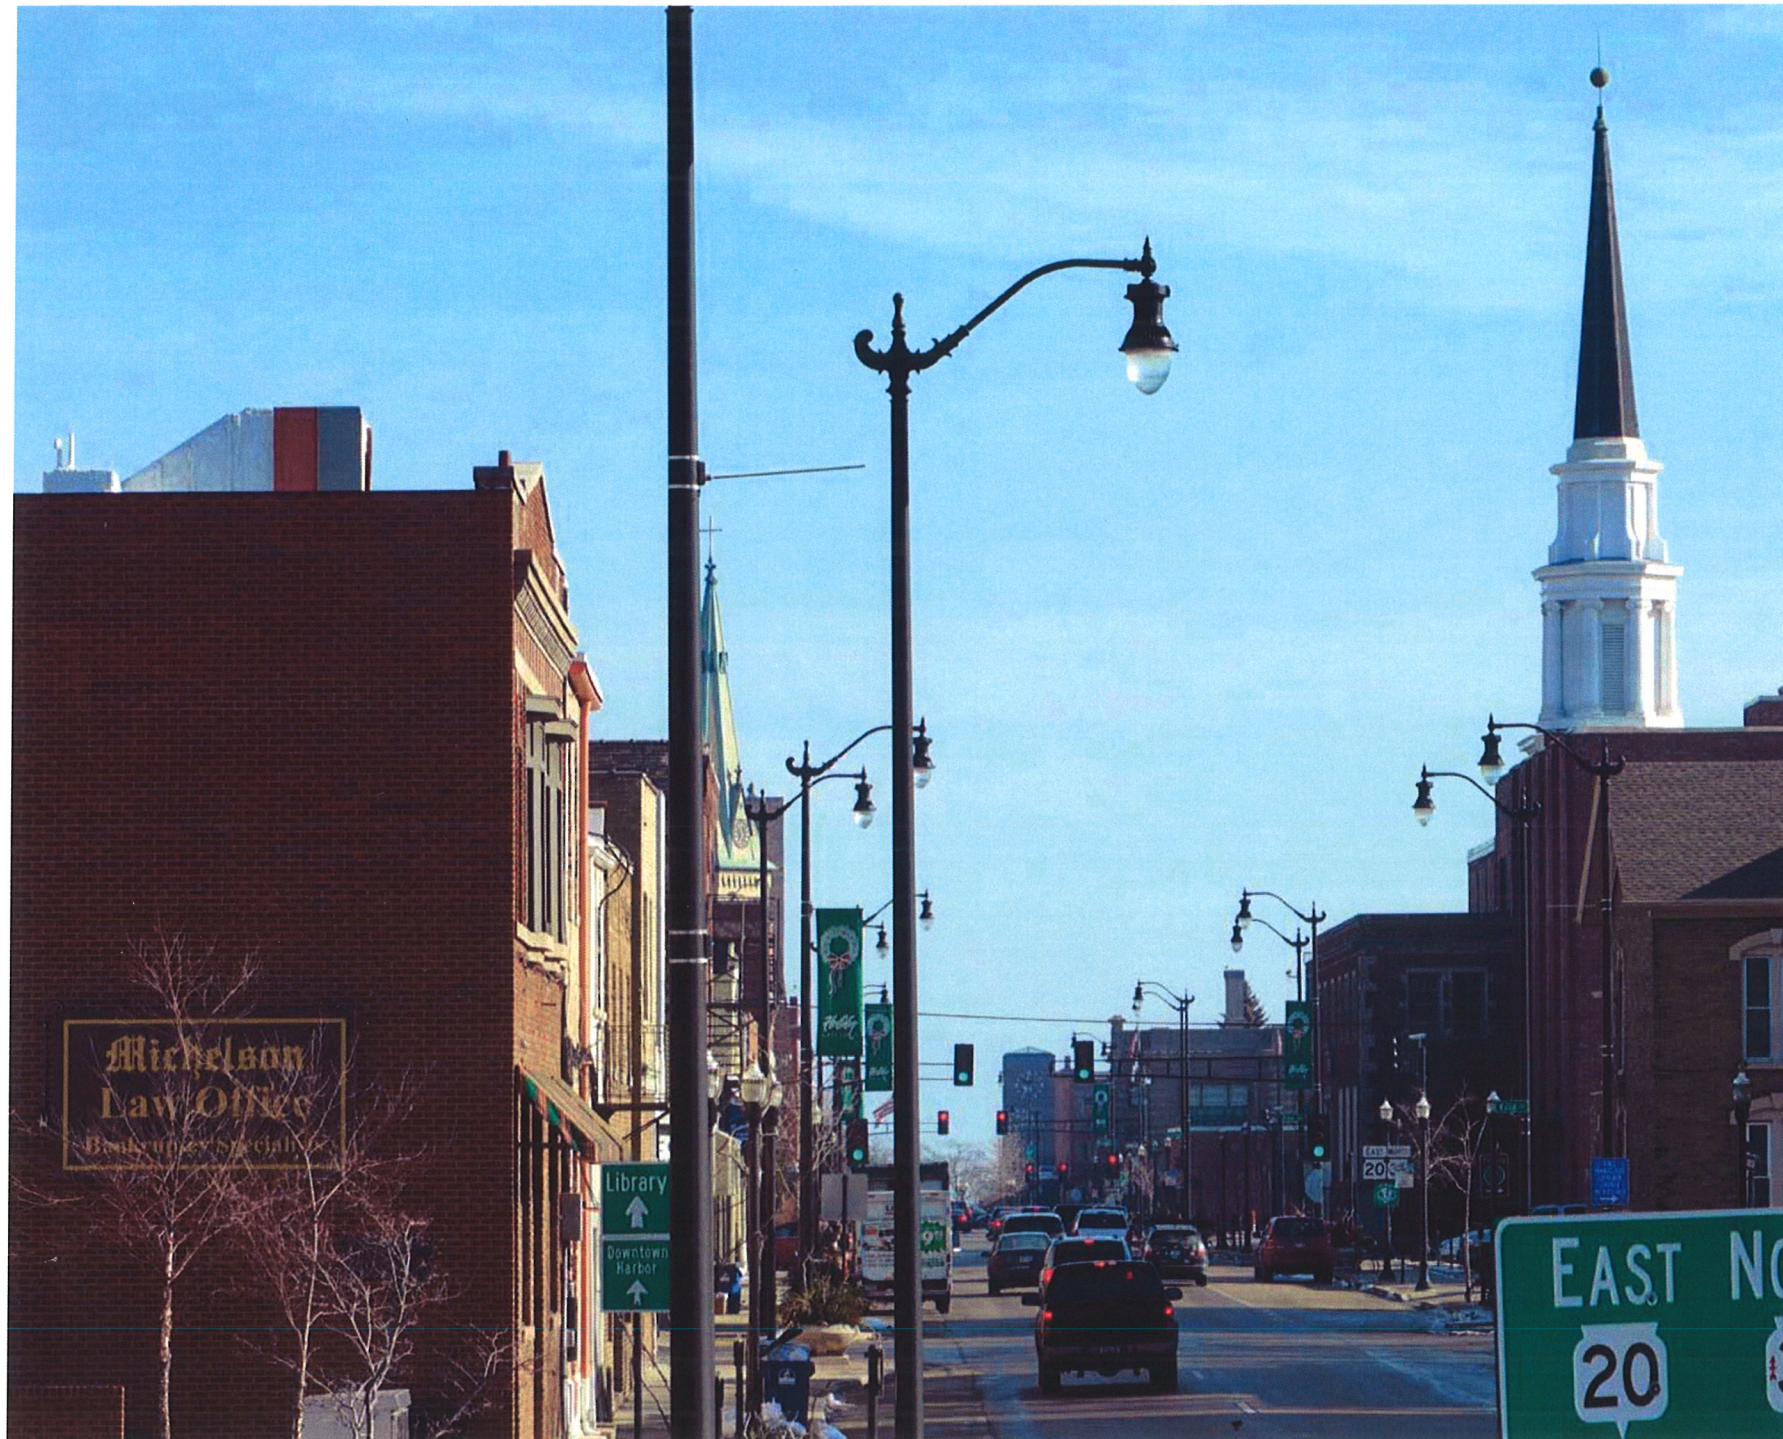
The east and west views of the stair hut suggest different blending strategies- the view east from City Hall favors the terra cotta which blends with the red brick context, while the view from the Lake favors the cream city beige

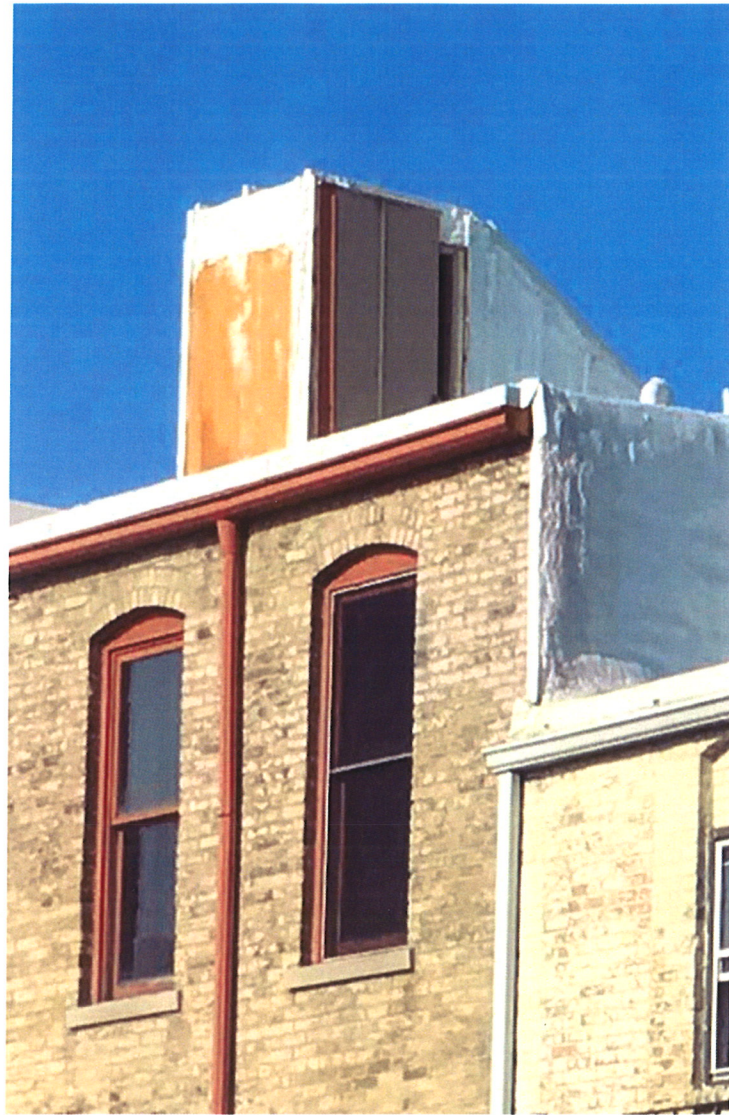
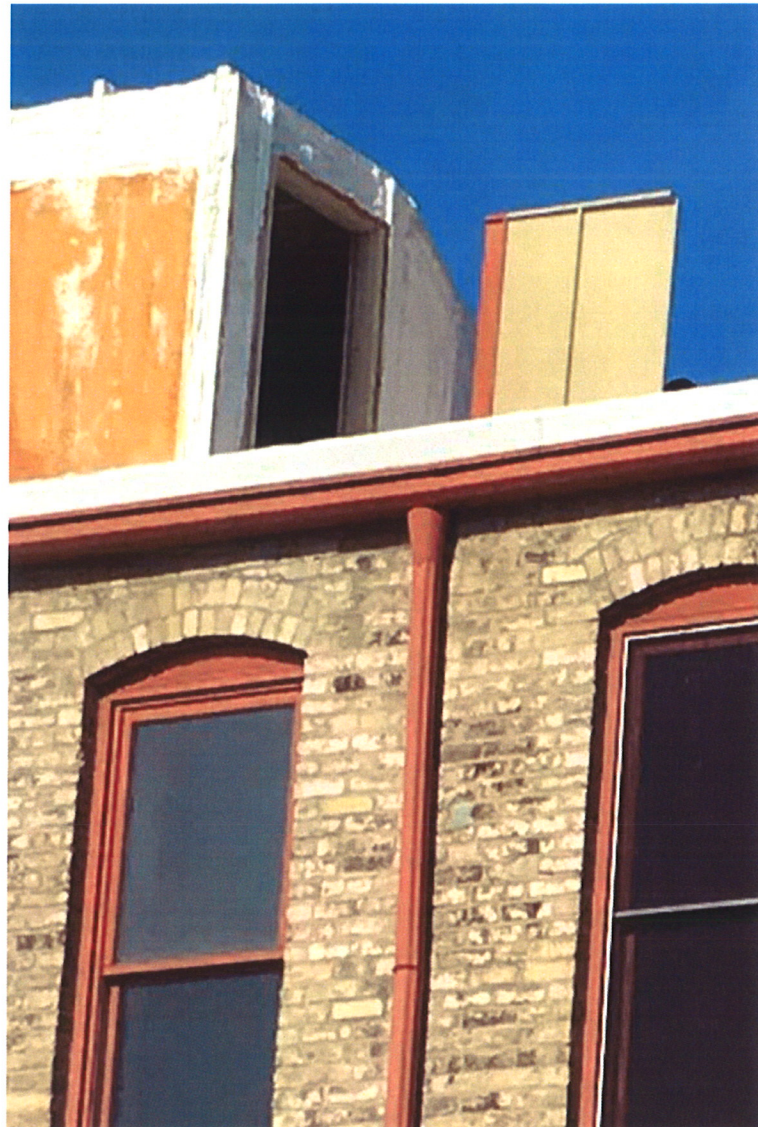
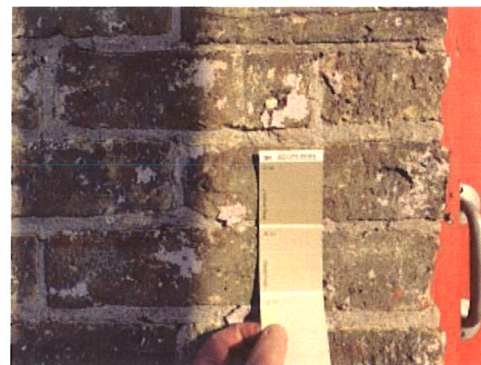
Above the Greenbrier Beige in shadow and sun.

The photo-collage to the right illustrates the use of the beige on the eastern face of the stair structure
