Fire Station 6 Space and Operational Issues

City of Racine
Fire Department - Fire Station 6
 Space Needs Program

SECTION 5.6
FIRE STATION NO. 6
EXISTING BUILDING PLANS

**SECTION 5.6
FIRE STATION NO. 6 -
EXISTING CONDITION
ANALYSIS**

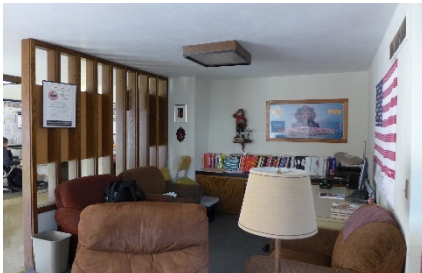
Office Area in Dayroom

- An office is located within the officer's bunk within the private side of the station. Space is small, and access is congested through the living quarters.
- Additional office area is located adjacent to the dayroom in the living quarters. The space is appropriate for use but does not provide a privacy if required.

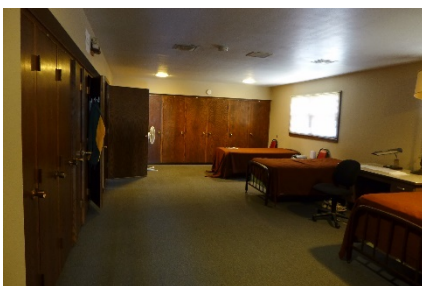
Private Quarters – Bunk Room

- The department utilizes a rack room concept for its private (sleeping) quarters at all stations. The room contains bunks and lockers for all shifts. This is the only station that does not provide bunks for each person on shift. This layout maintains the most flexibility but does not address gender concerns within the facility.
- No female toilet/ shower facilities are provided within the facility.
- Separate changing rooms should be provided to accommodate gender.
- Toilet/ shower conditions are undersized.

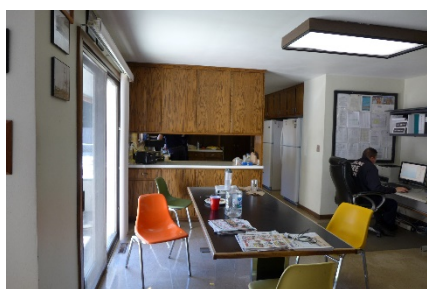
- The living quarters are located adjacent to the bay on the first floor. A buffer zone is provided between spaces to maintain isolation between cold and hot zones.
- The kitchen and dining room is undersized for staff use, not providing enough storage.
- The facility has multiple levels that are not accessible.

View of dining and kitchen

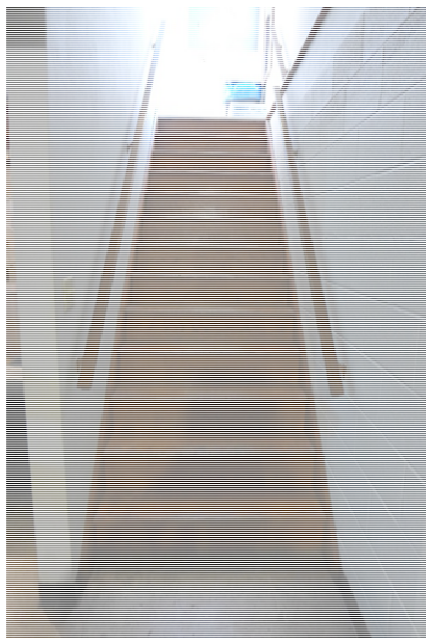
Staircase to basement

The front entrance door currently swings into the building. This door needs to be replaced with a door that swings to the exterior to allow for egress from within. Additionally, the door at the top of the staircase needs to swing in the opposite direction for egress. It is recommended that this door be removed as there is not enough clear floor space for this door to swing out.
