RE: 441 Lake Avenue Facility Assessment  
Carl Walker Proposal No. R1-18-063

Carl Walker, a division of WGI (Carl Walker), has completed a pre-sale condition assessment review of the facility at 441 Lake Avenue in Racine, Wisconsin. The review was performed to provide an overall assessment of the structure, as well as review the performance of repair and maintenance work completed in recent years.

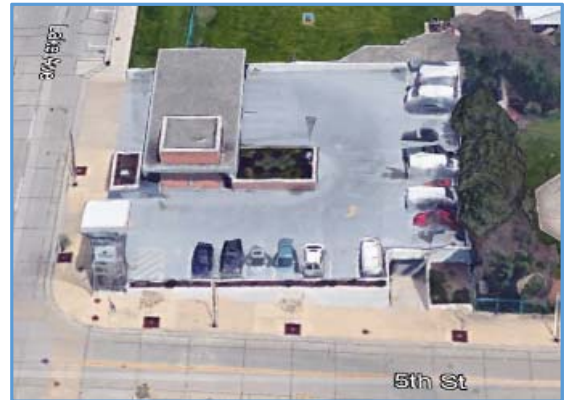
The Johnson Bank Drive-thru parking structure located at 441 Lake Avenue in Racine, Wisconsin consists of a single supported level and an on-grade level with overall dimensions of 118'x118'. The supported level of the facility, accessed from Lake Avenue to the west, includes four drive-thru lanes and provides 16 parking spaces. The lower level, accessed from 5<sup>th</sup> Street to the south, is utilized as a storage area.

The parking structure is constructed of cast-in-place conventionally reinforced concrete slabs, joists, and columns. An enclosed stair tower is located in the southwest corner of the structure. A bank building, drive-thru lanes, and planter boxes are constructed on top of the parking structure. It is our understanding that the bank building and teller lanes, with the exception of the ATM location will be demolished in the near future. In addition, the large planter box will be lowered. These modifications are intended to reduce the overall loading of the structural support system.
